# Oath to Burrowbridge Dredging and Associated Activities

## APPENDIX 7C: WATER FRAMEWORK DIRECTIVE REGULATORY COMPLIANCE ASSESSMENT

## **Stathe to Burrowbridge Dredging Proposals Water Framework Directive Assessment**

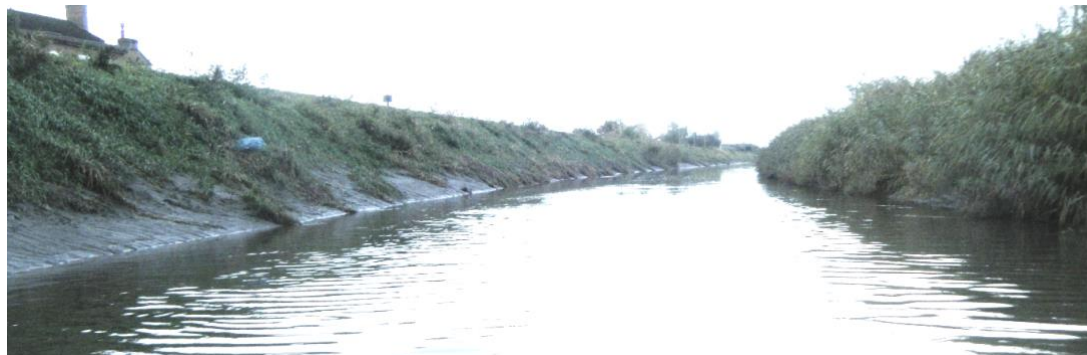
**Figure 1**

Visual observations downstream of the confluence of the Parrett and the Tone at Burrowbridge showing that reeds often come down to the water's edge at the more landward end of the water body, with steep bare sediment bays between reed zones.

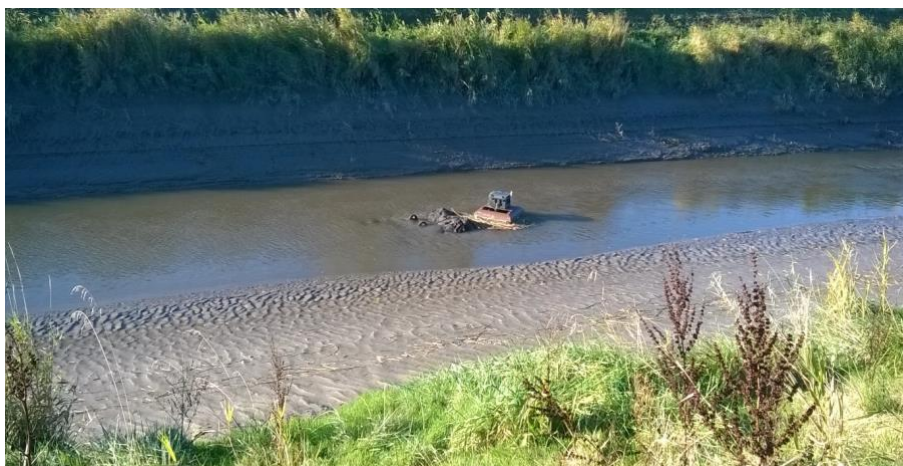
**Figure 2**

Visual observations at Moorland (further downstream from the proposed dredging location) showing that reeds are rarely present along the LW mark at this seaward end, with wide shallow angled bare mud zones dominating.

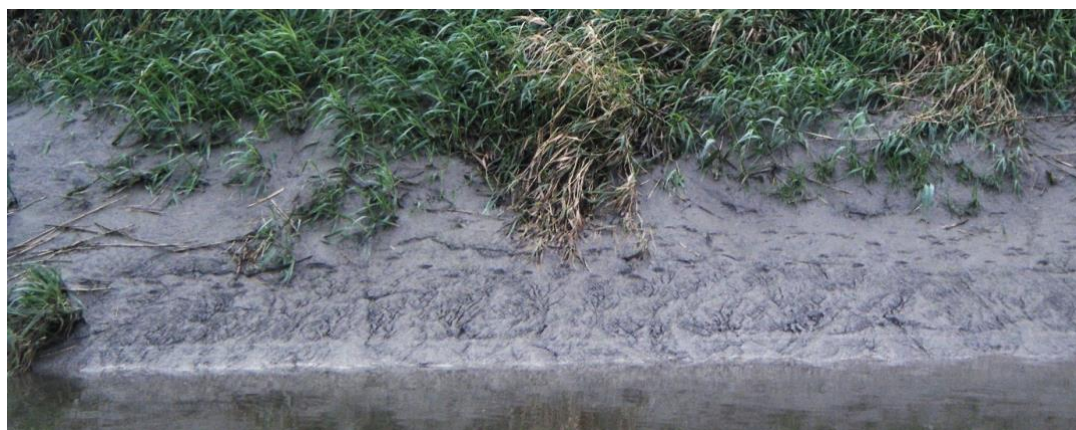
**Figure 3**

Visual observations of intertidal bed features at Burrowbridge (lateral and longitudinal features, likely rain-wash rills).

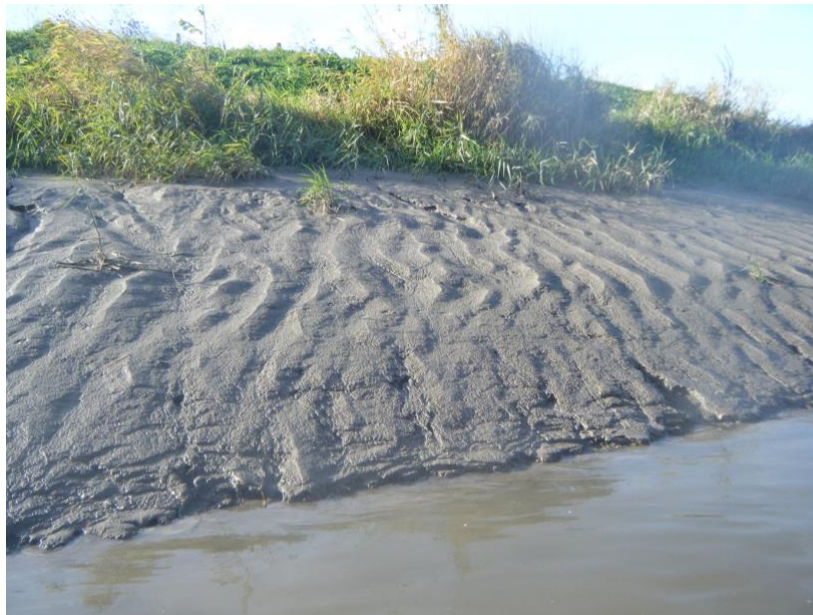
**Figure 4**

Visual observations between Burrowbridge and Moorland on the intertidal mud surfaces, showing transverse ripple marks and micro-cliffing

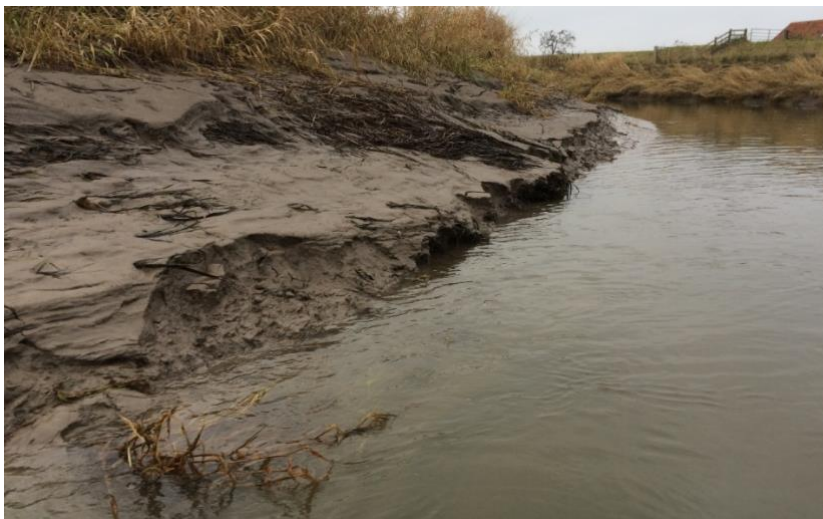
**Figure 5**

Sedimentary features between Burrowbridge and Moorland. Intertidal sediment surfaces following strong erosion of inner bends with large slump features.

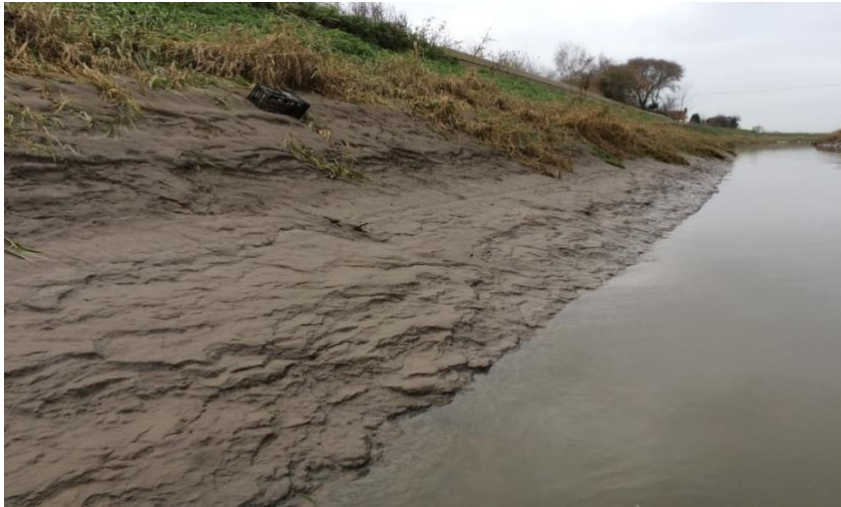
**Figure 6**

Sedimentary features between Burrowbridge and Moorland, straight reaches with wide scoured sediment surfaces, less prone to slumping.

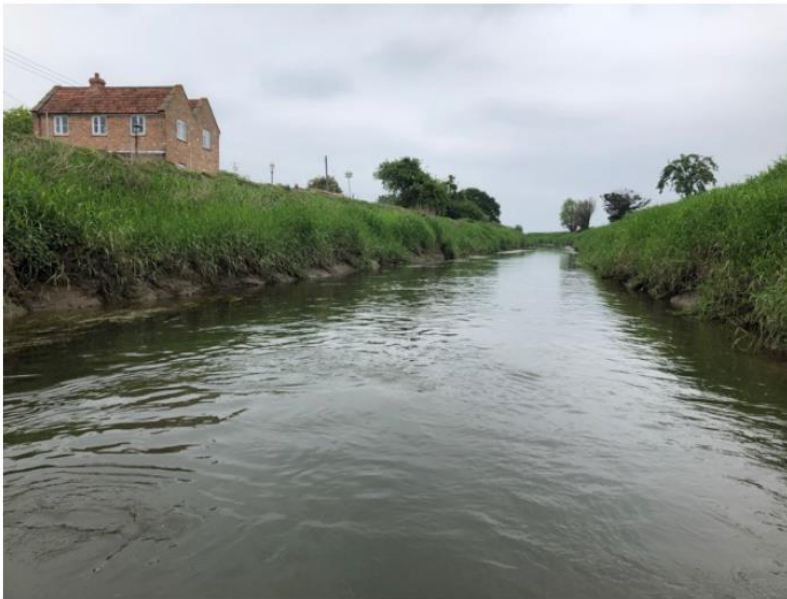
**Figure 11**

Typical view showing re-sectioned and re-aligned planform, influence of tide on water levels, smooth flow, no in-channel habitat/features from trees.

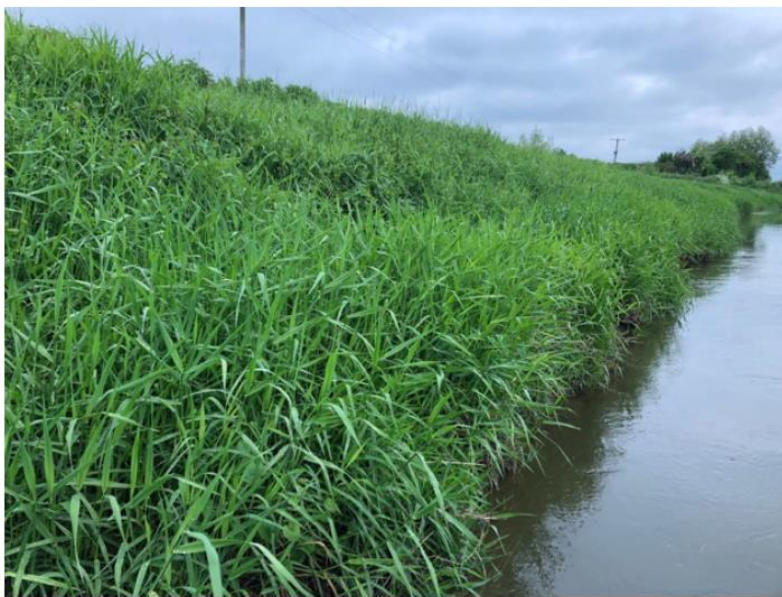
**Figure 12**

Typical view showing increased proximity to upper bank vegetation at higher/freshwater flow tidal states.

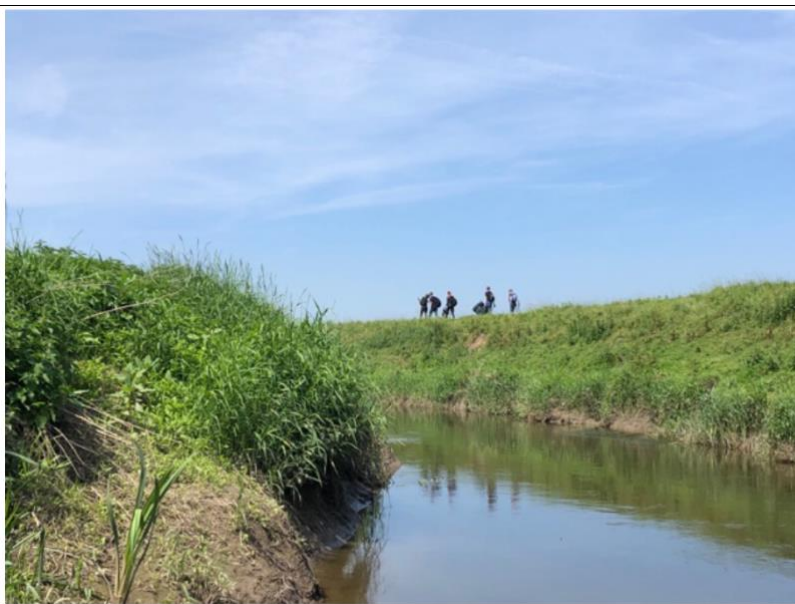
**Figure 13**

Typical view of gentle bend without typical meander geomorphology.

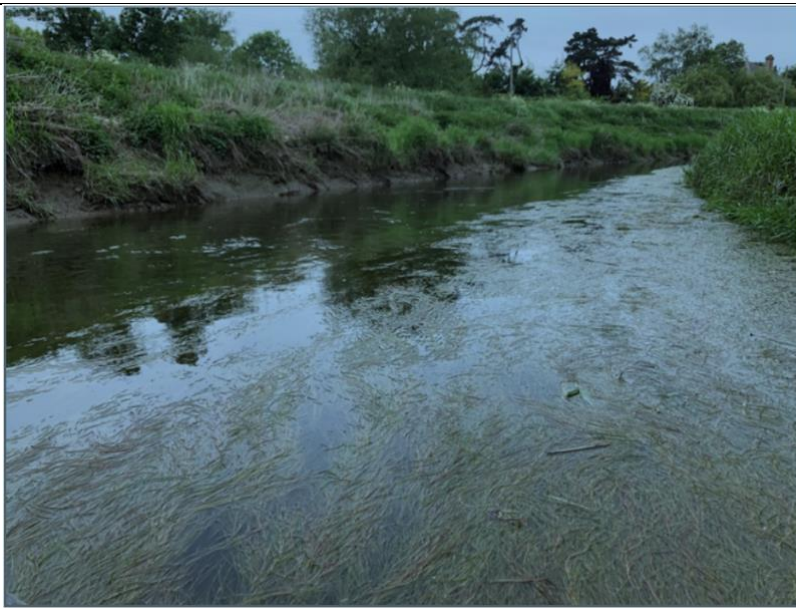
**Figure 14**

Typical appearance of submerged aquatic macrophyte bed at lower flows/tidal states, providing a dense submerged and lower energy habitat for fish and invertebrates with greater flow passing to the side.

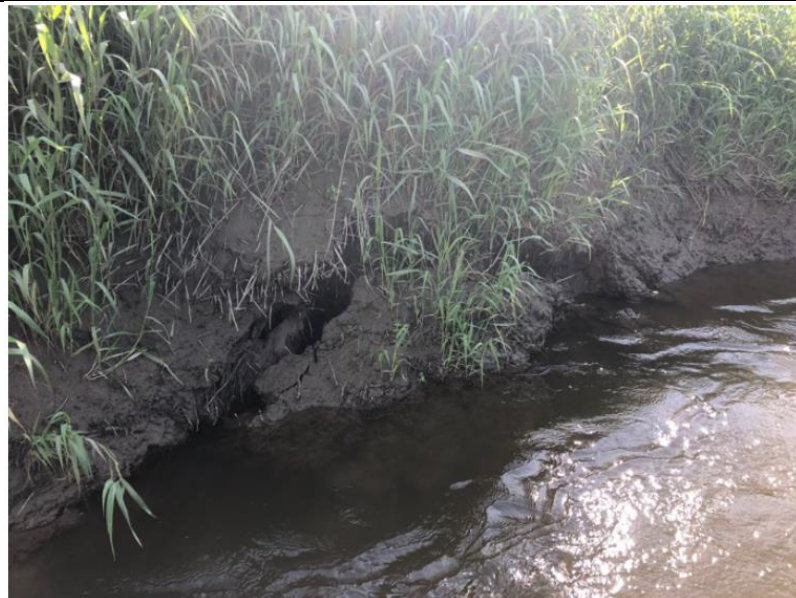
**Figure 15**

Bank failure in progress resulting in the provision of fresh sediment in-channel (potential for localised depth reduction until transported) and small embayment/overhang that could develop further during higher energy flow events.

- Some variation in lower bank stability as a result of weathering and erosional activities. These are typically more notable below Staithe Bridge. Slab/cantilever and slump failures cause a more irregular bank form resulting in small backwaters or embayments (where collapsed sediment has been transported downstream). Narrower cross-sections or pinch points are present in the lower reaches, where bank failures have become stabilized and vegetated, which increase flow velocities under lower tidal states. Some overhangs are present causing some limited areas of shading, and some submerged overhangs are present as well. See **Figure 15-16**.

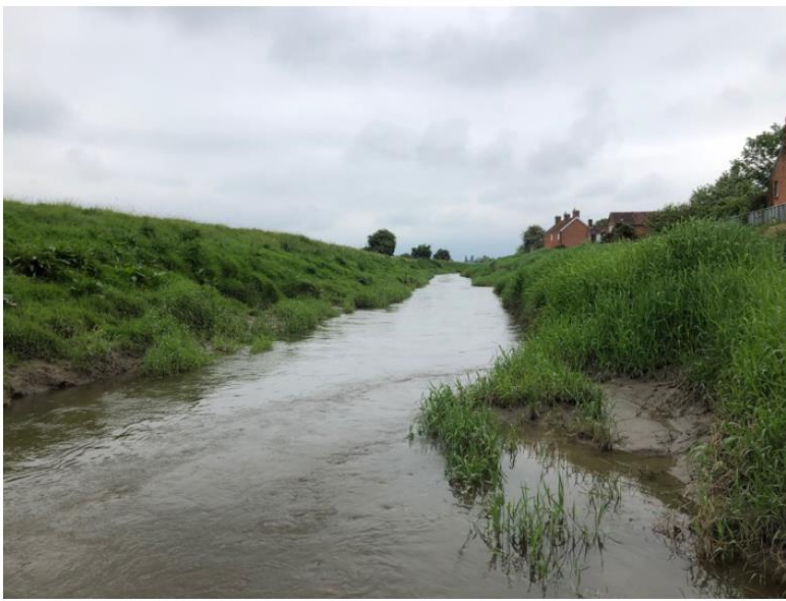
**Figure 16**

Stabilised and vegetated bank collapse creating shallow backwater/embayment at higher flow conditions and a narrowing/pinch point in the channel at lower flow conditions, locally increasing flow velocity.

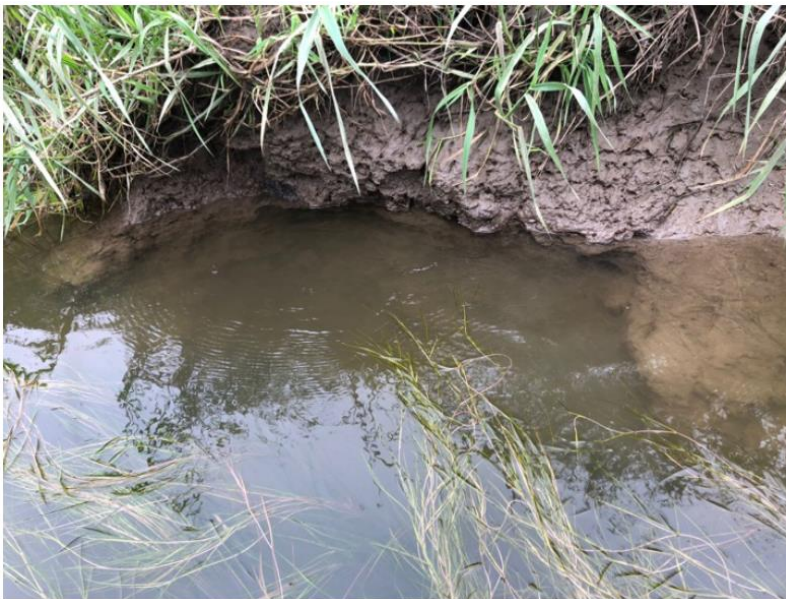
**Figure 17**

Submerged lower energy feature caused by bank failure, adjacent to macrophyte bed.

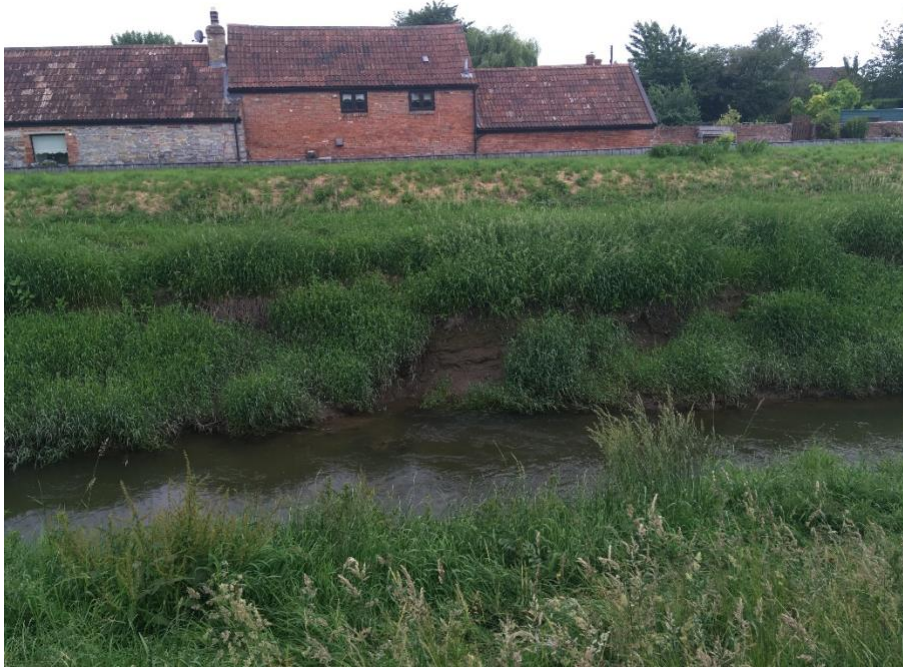
Figure 2

Fish habitat features (pinch points and local erosion/instability). To be recreated with excavators or retained where no dredging is planned.

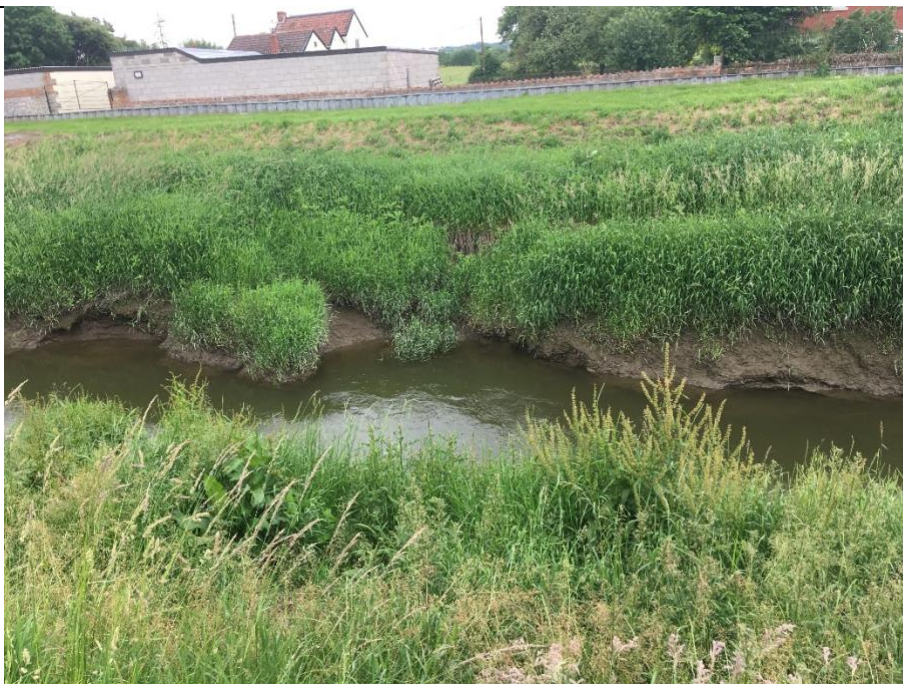
Figure 3

Fish habitat features (pinch points and local erosion/instability). To be recreated with excavators or retained where no dredging is planned.

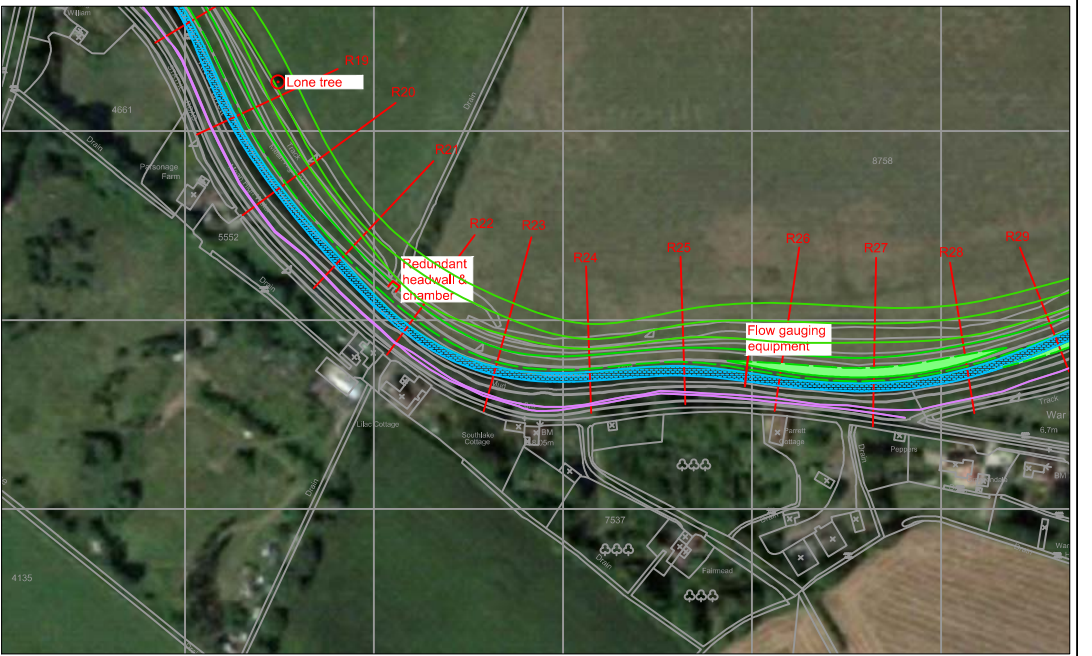
## R21

Section R21 is a temporary spillway position. Fill for this location is to be stockpiled on adjacent placed & compacted fill ready for future reinstatement of the spillway. See specification for details.
