# Oath to Burrowbridge Dredging and Associated Activities

## Volume 3: Appendices Part 8 Section 2

## Oath to Burrowbridge dredge - working area

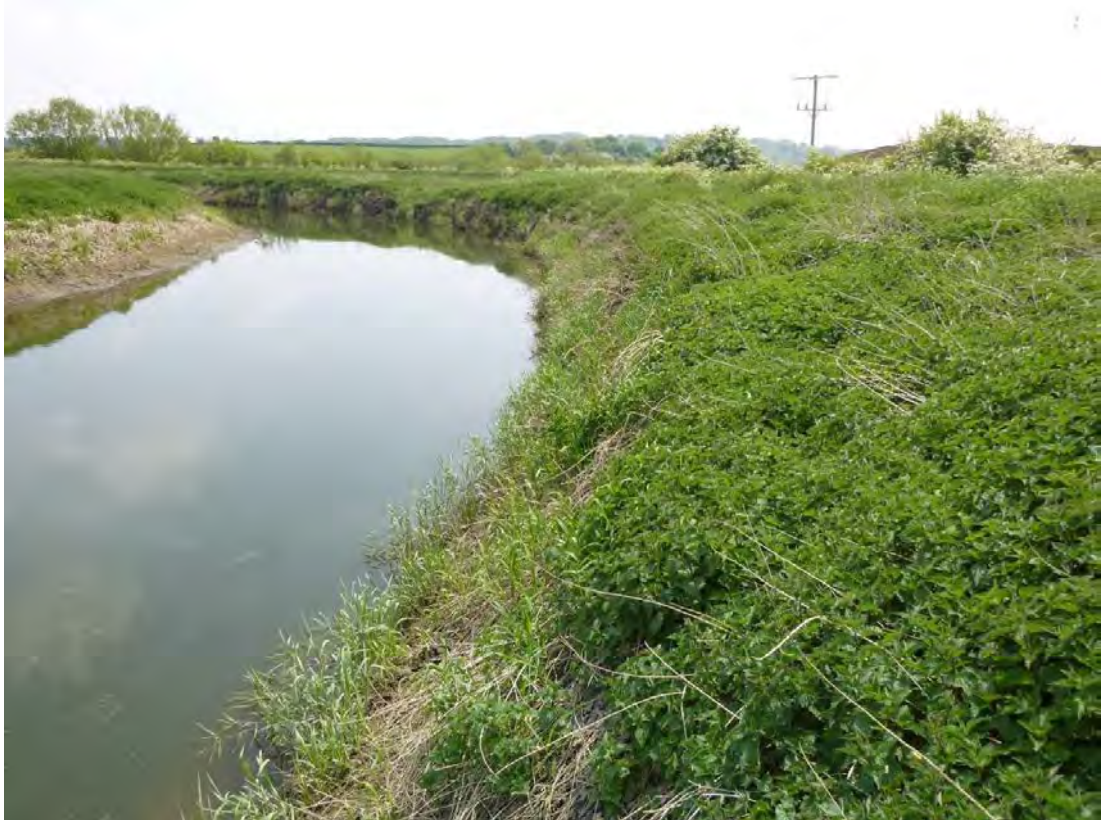
**Photo 2. River Parrett Sample Location 2 upstream from ST 37870 28182; showing a steep substrate, poor habitat structure and reed canary-grass limited to a narrow fringe on the water margin.**

- 6.4.1 Sample Location 2 comprised a 200 m section of the River Parrett bank upstream from Stathe House. This was surveyed from the Stathe bank, from ST 37853 28256 to ST 37937 28145. As with Sample Location 1, this is a locality with previous records of hairy click-beetle, but the habitat composition and structure were materially identical

to Location 1 and no adults or larvae were recorded. Photo 2 illustrates the character of the habitat present in Sample Location 2.

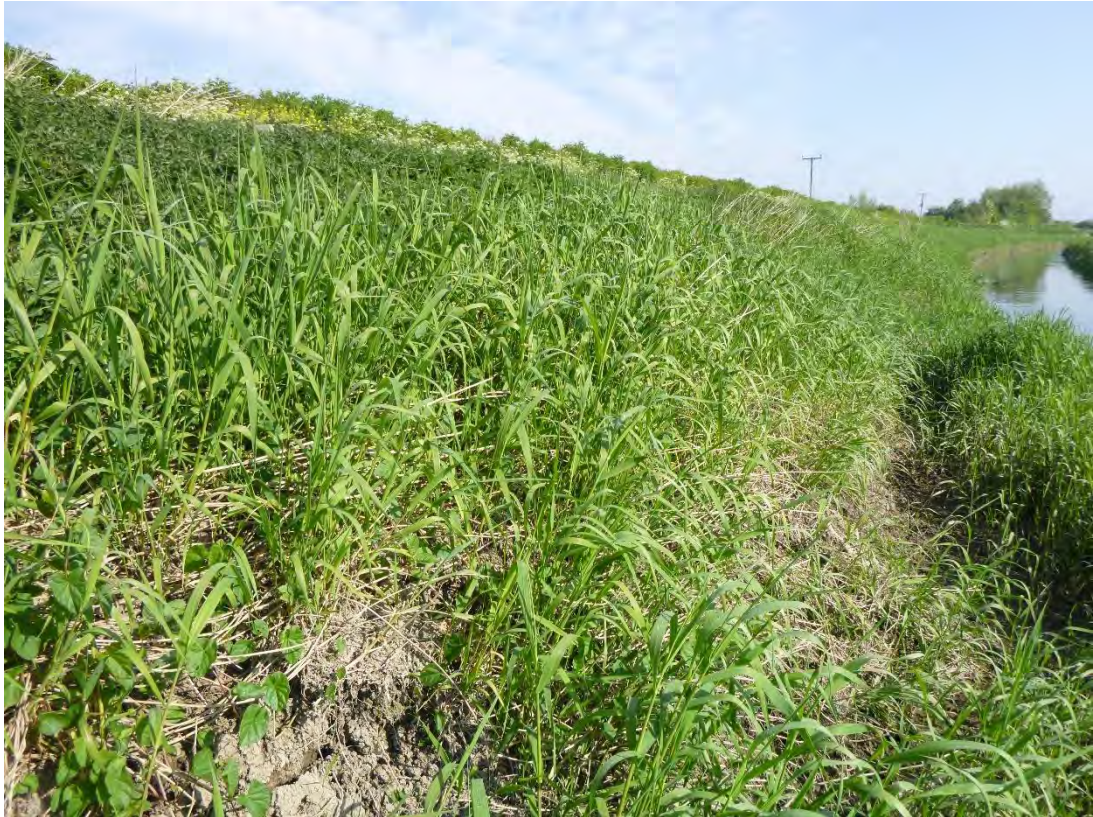
**Photo 3. River Parrett Sample Location 2 downstream from ST 36557 29555; where two adult hairy click-beetle were swept.**

6.5.2 On the Stathe bank, Sample Location 3 comprised a 120 m section of the River Parrett bank downstream from Stathe Bridge from ST 37524 29098 to ST 37483 29210. The habitat here broadly accords with that known to be exploited by the species, comprising a monotypic 2-3 m belt of unmanaged reed canary-grass growing on a shallow lower channel face with a gentle *c.* 10-20° slope (see Photo 3). This is a locality with previous records of hairy click-beetle, and in 2018 two adults were swept

in one 10 m stretch. In addition, three possible hairy click-beetle larvae were exposed at 20 cm depth in a soil pit.

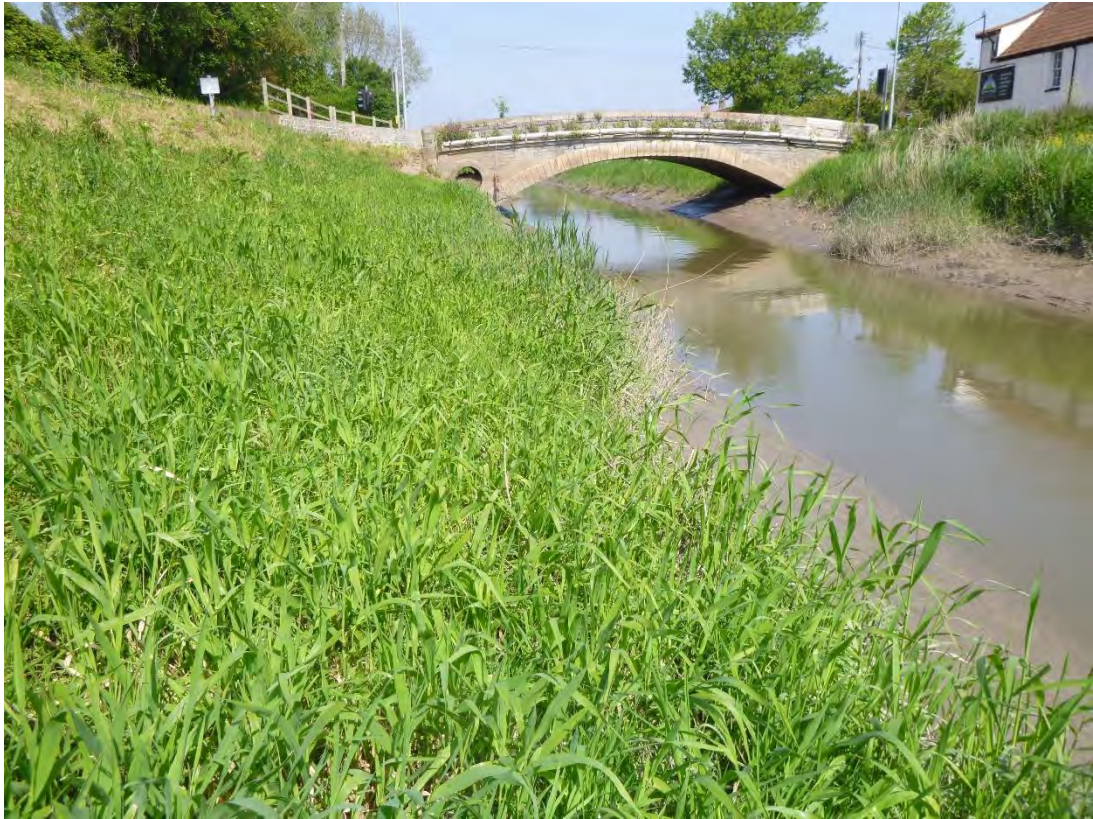
**Photo 4. River Parrett Sample Location 6 downstream from ST 35795 30341; the reed canary-grass had recently been cut close to the river channel.**

- 6.8.1 Sample Location 6 comprised a 280 m section upstream of Burrowbridge from ST 35741 30425 to ST 35805 30164. Although the lower channel face is shallow with a *c.* 20° slope and has good quantities of reed canary-grass, much of the vegetation has been cut close to the river channel and is therefore not typical of the habitat structure exploited by hairy click-beetles. Despite annual records of hairy click-beetle from Environment Agency surveillance between 2010 and 2016, no adults or larvae were recorded. Photo 4 illustrates the habitat present.

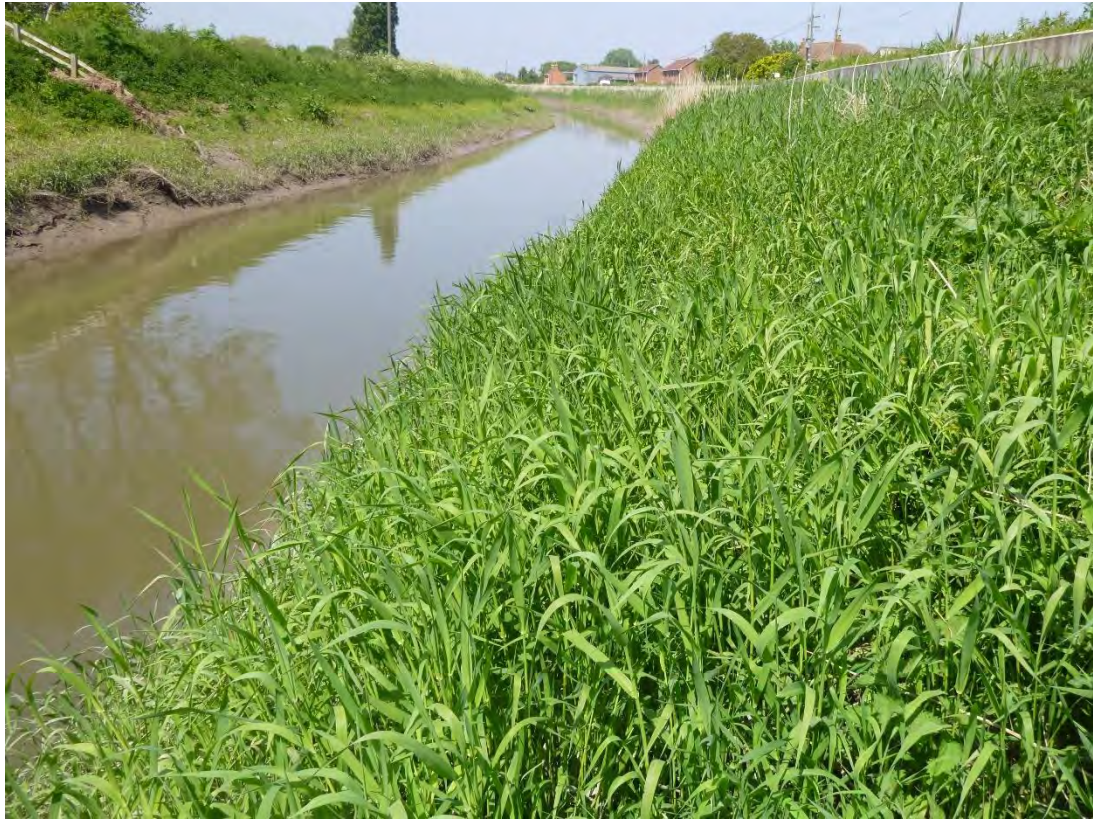
**Photo 5. Sample Location 7 downstream from ST 35720 30493; where three adult hairy click-beetle were swept.**

- 6.9.1 Sample Location 7 comprises a 250 m section of the River Parrett bank downstream of Burrowbridge from ST 35749 30449 to ST 35602 30641. This sample was surveyed on the Burrowbridge side alone. The habitat here comprised a 3-4 m belt of unmanaged reed canary-grass dominated vegetation with common reed, growing on a shallow lower channel face with a *c.* 20-30° slope. This is a locality with previous records of hairy click-beetle, and three adults were recorded in 2018, but no larvae were encountered in a soil-pit. Photo 5 illustrates the habitat present in 2018.

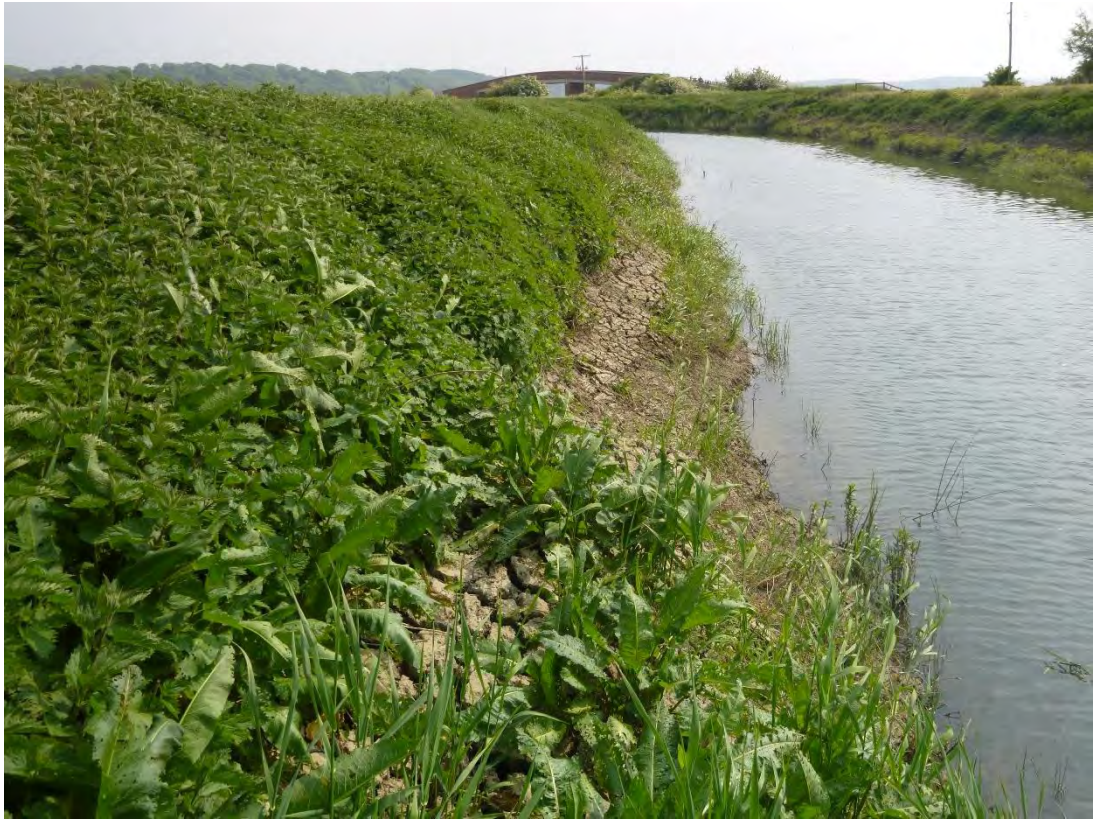
**Photo 6. River Parrett downstream from ST 38143 22977; unmanaged bank with poorly developed reed canary-grass zone.**

- 6.10.2 A 430 m section of river bank to Oath Lock was surveyed on the Burrowbridge side, from ST 38119 28143 to ST 38275 27886. The habitat here comprises dense ruderal vegetation on the upper bank, and scattered reed canary-grass along a largely bare 1-1.5 m strip above the river channel (see Photo 6). No adult hairy click-beetles were recorded.

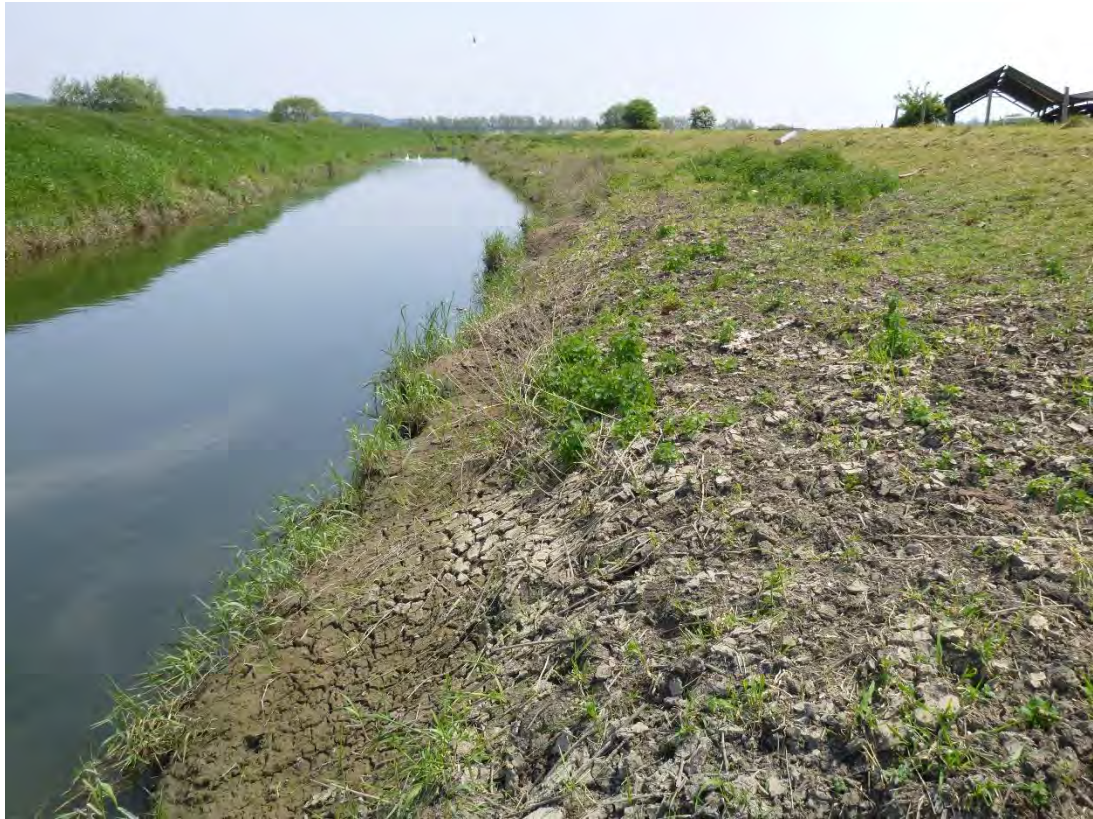
**Photo 7. River Parrett upstream from ST 37946 28141; heavy poaching from cattle grazing, with limited growth of reed canary-grass.**

- 6.10.3 The Stathe bank of the River Parrett between ST 37937 28143 and ST 38113 27943 was visually inspected from adjacent sections, and the opposite bank. This section was heavily grazed by cattle, with limited growth of reed canary-grass (see Photo 7) and the habitat is not typical of that known to be exploited by hairy click-beetles.

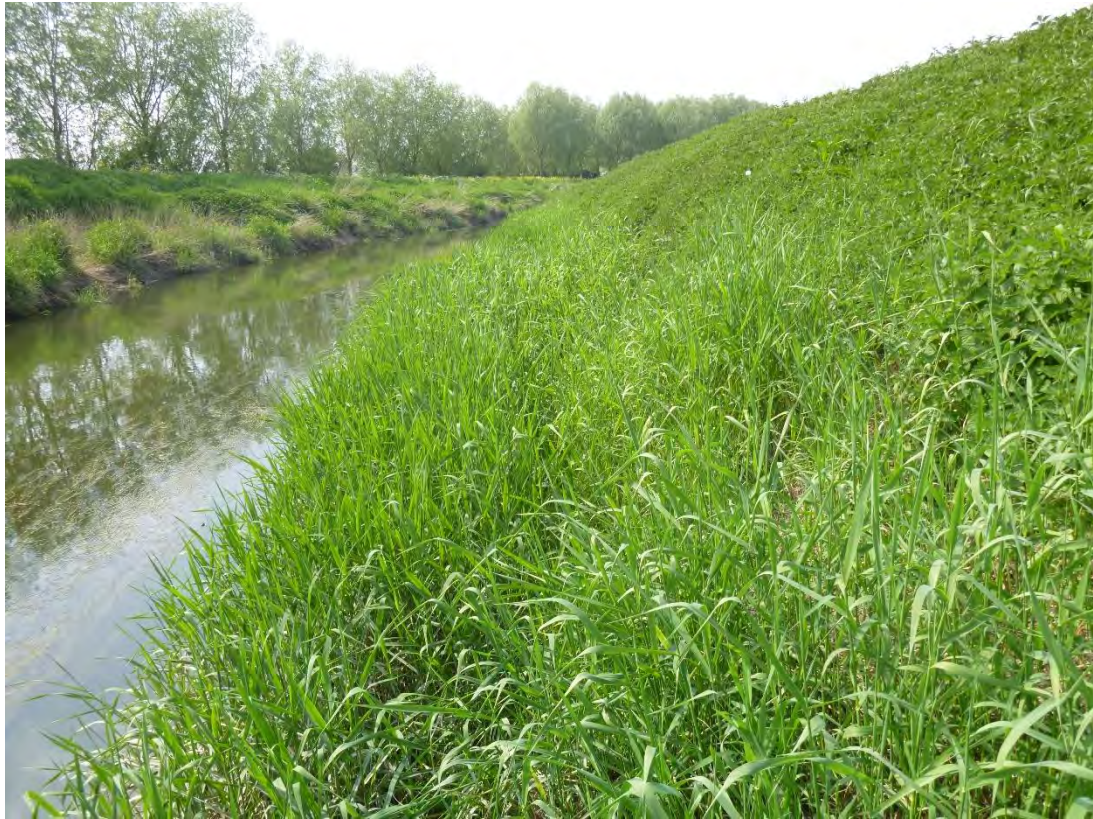
**Photo 8. River Parrett downstream from at ST 37923 28162; where an adult hairy click-beetle was swept.**

- 6.10.4 A 1.3 km section of river bank upstream from the eastern end of Southlake Moor was surveyed on the Burrowbridge side, from ST 37538 29099 to ST 38119 28143. The habitat here comprises a monotypic 1-3 m belt of unmanaged reed canary-grass growing on a shallow lower channel face with a *c.* 20-30° slope (see Photo 8). Fourteen adult hairy click-beetle were recorded, but no larvae were encountered in a soil-pit.

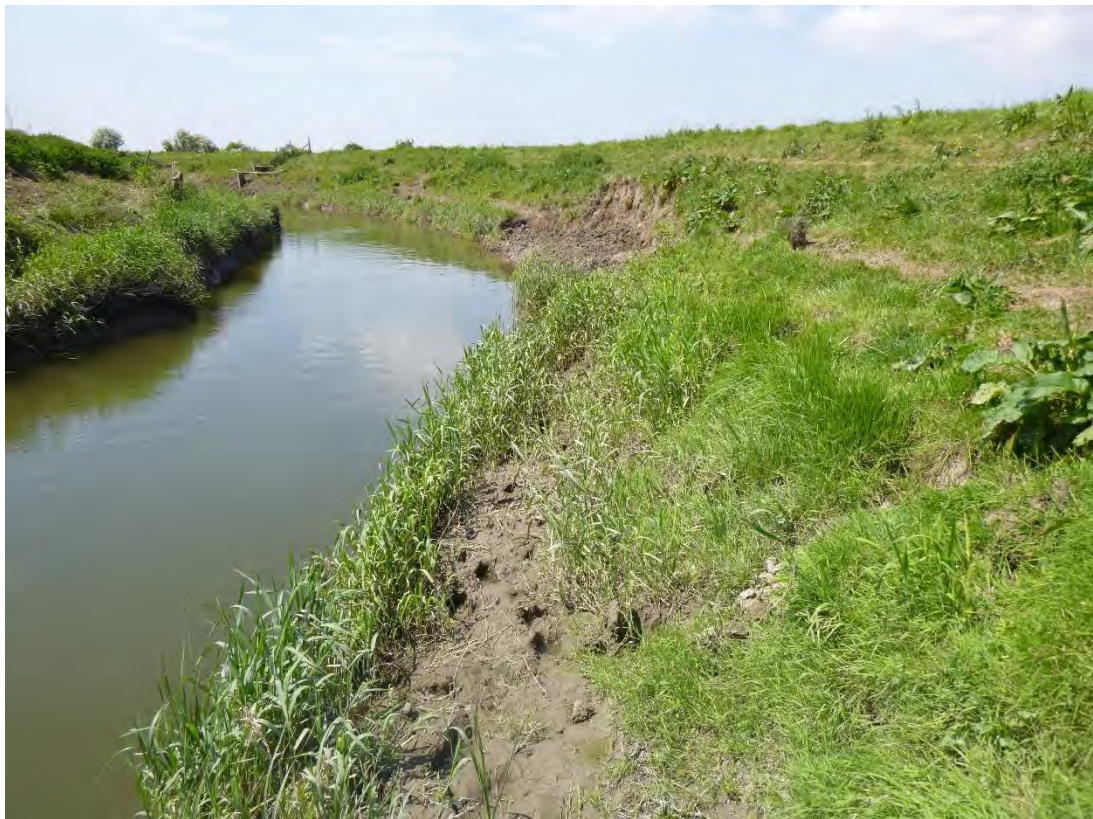
**Photo 9. River Parrett downstream from ST 37194 29553; poaching from cattle grazing, with limited growth of reed canary-grass.**

- 6.10.6 A 2.2 km section of river bank upstream from Burrowbridge was surveyed on the Burrowbridge side, from ST 35811 30348 to ST 37550 29427. The habitat throughout was heavy poached due to cattle grazing on Southlake Moor, and reed canary-grass was present as a fringe less than 1 m wide, with culms grazed down, and large patches of bare ground and compacted soil (see Photo 9). Two adult hairy click-beetles were recorded opposite the western half of War Moor, one of which was covered in mud.

It is likely that its underground overwintering site was compressed by cattle trampling. This is in contrast to the other 25 adult specimens during this survey which had pristine pubescence. There is no information available about the effects of cattle trampling on hairy click-beetle larvae, although there is some research about other invertebrates. Numbers of larvae for the soil-inhabiting crane-fly *Molophilus ater* were lower in trampled peat along a footpath than in adjacent untrampled ground (Bayfield, 1979). Two out of fourteen soil cores produced adults, compared with nine out of fourteen from undisturbed ground (Bayfield, 1979). It seems likely that hairy click-beetle larvae might be killed by heavy compaction from grazing, as click beetle larvae in the present survey were found at shallow depths (c. 10-20 cm).

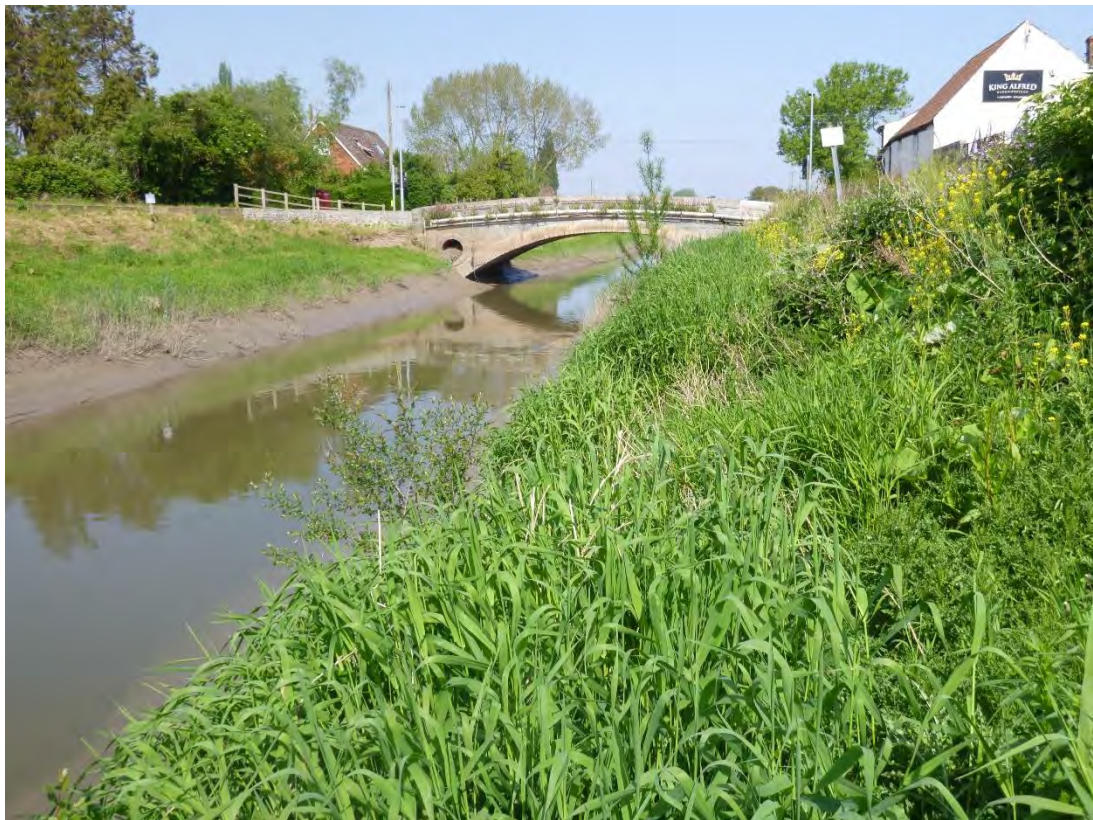
**Photo 10. River Parrett downstream from ST 35784 30389; where an adult hairy click-beetle was swept.**

- 6.10.8 A 100 m section of the River Parrett bank upstream from Burrowbridge was surveyed on the Burrowbridge side, from ST 35754 30436 to ST 35811 30348. The habitat here comprises diverse ruderal vegetation and a 1-2 m belt of unmanaged reed canary-grass. The lower channel profile is steep (*c.* 45°), with a slightly shallower mid-slope (*c.* 35°) (see Photo 10). One adult hairy click-beetle was recorded.

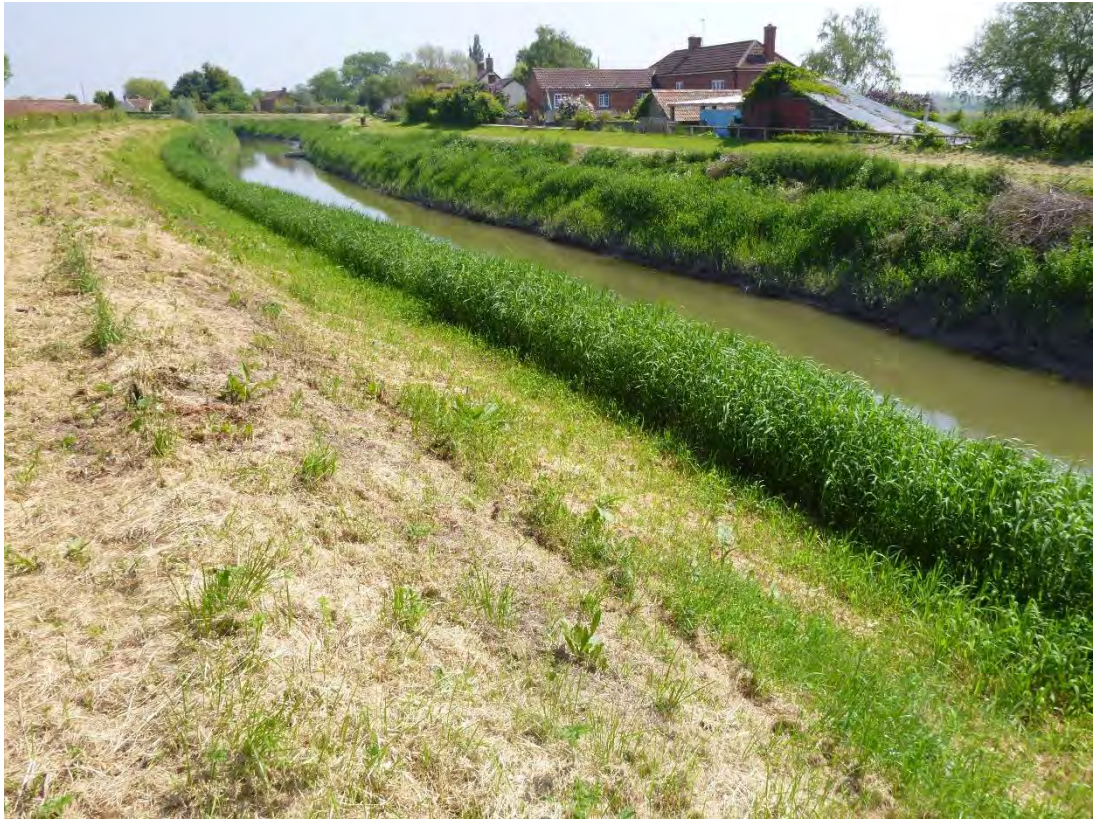
**Photo 11. River Tone downstream from ST 35617 29955; with a 2 m belt of reed canary-grass left unmanaged, after cutting on the upper bank.**

- 6.11.2 The habitat on the south bank of the River Tone between ST 35798 30144 and ST 35396 29721 comprised a monotypic 2-3 m belt of reed canary-grass growing on a shallow lower channel face with a *c.* 20-30° slope. Although the habitat composition and structure are typical of that known to be exploited by hairy click-beetles, access permissions had not been gained and no survey was performed. The status of the species in this location therefore remains unknown.

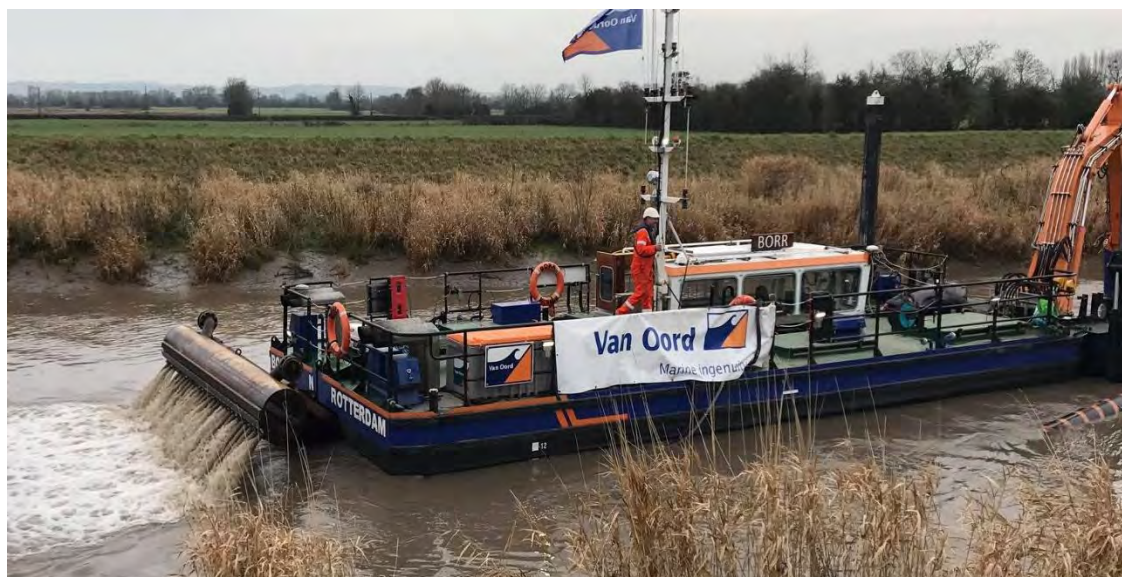
Figure 3. The BORR with the WID T-pipe pumping but elevated above the water surface.

The experimental dredging used two methodologies neither of which involved transport of spoil away from the river for disposal/reuse. The dredging created dense suspensions of the excavated material, which were naturally carried seawards by the (ebbing) tidal flow, augmented by the river discharge. The dredging was undertaken by Van Ord UK Ltd, using the vessel BORR (Figure 3).

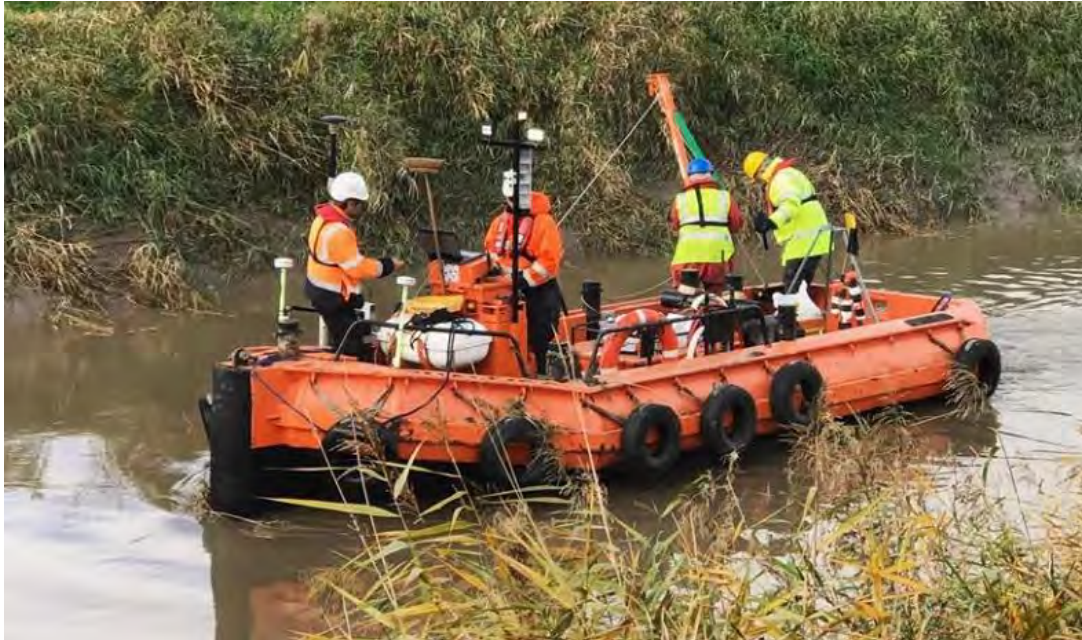
Figure 4. The CHALLIS 2 workboat showing the derrick used for the Owen tube.

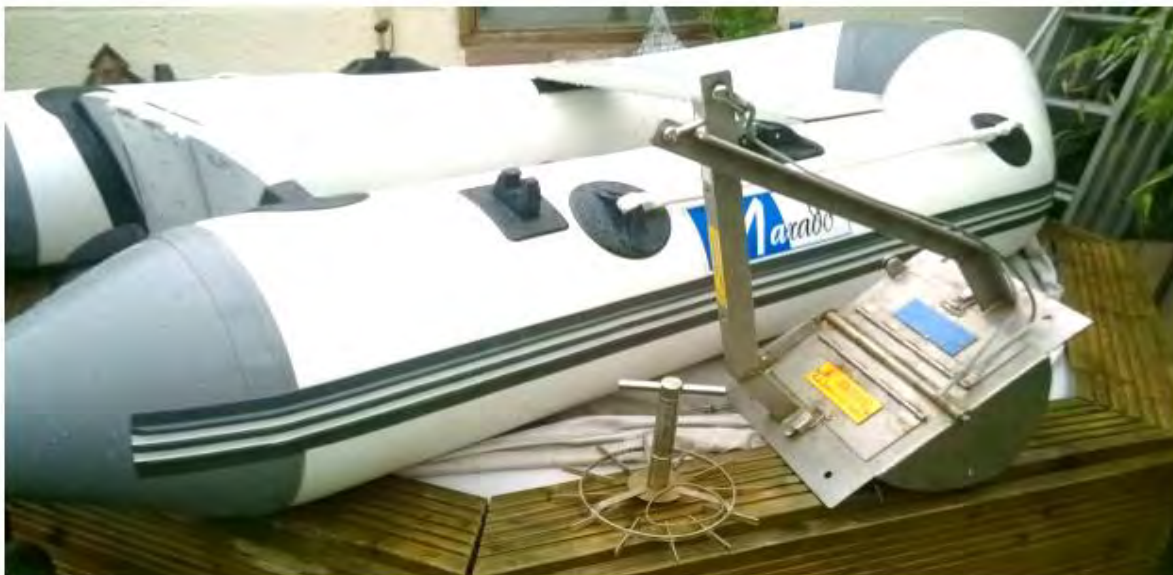
Figure 6. Inflatable dinghy, grab and shear vane used for the bed surveys.

With most samples it was possible to collect the mud undisturbed by inserting a 100ml volume core. This set-volume sample allowed determination of the *in-situ* bulk/dry density of the deposits.

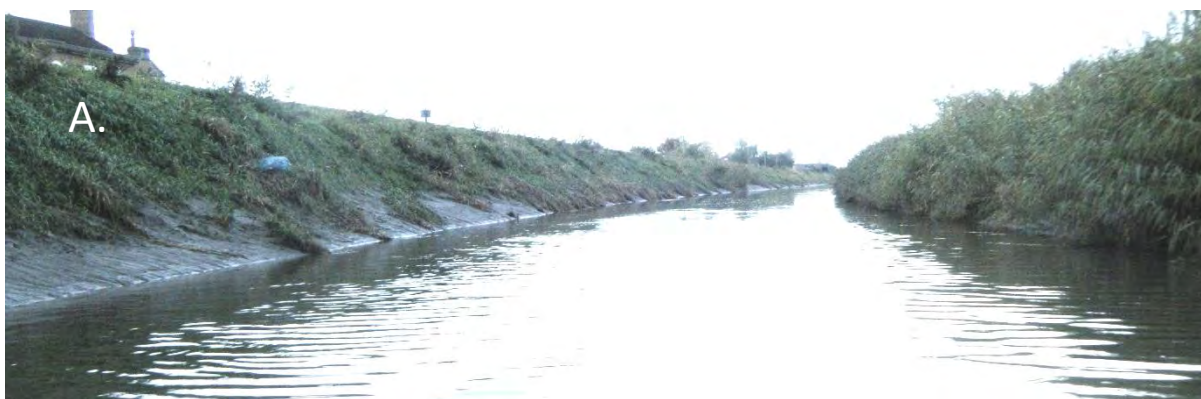
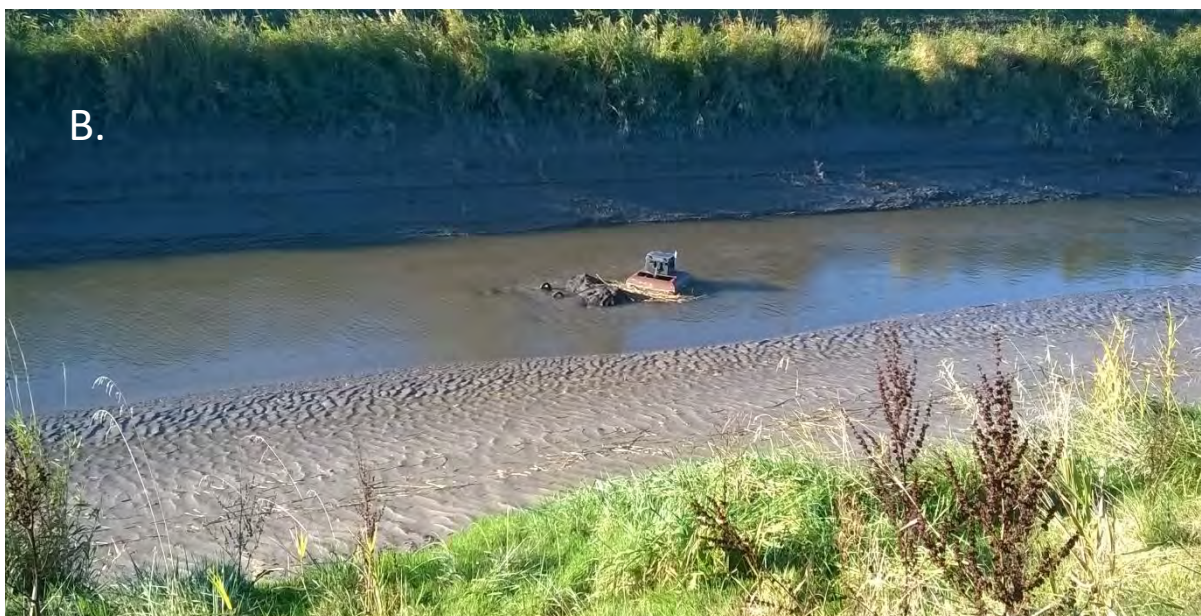
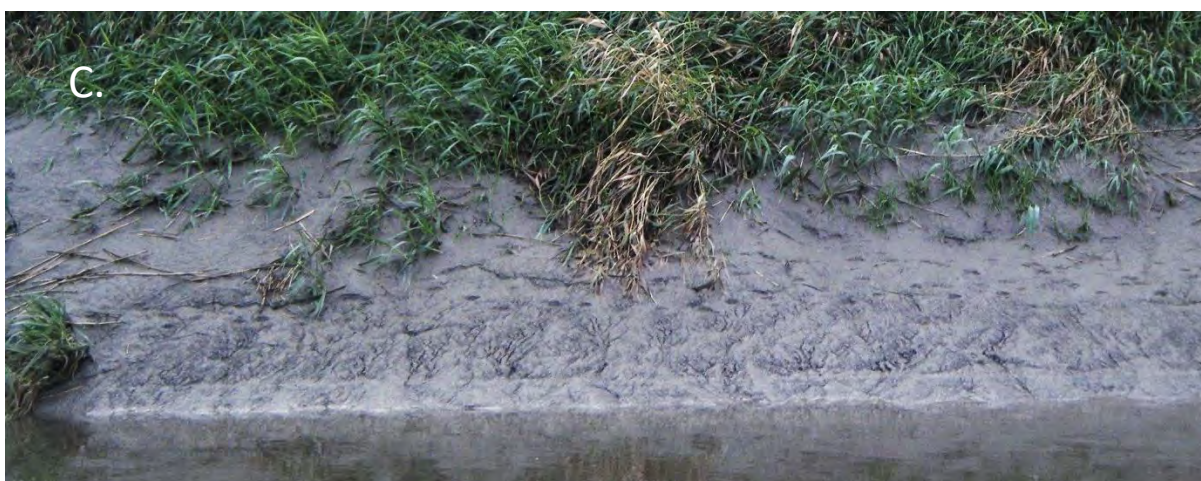
Figure 14. Photographs of key intertidal bed features, pre-dredge survey

- At the landward end of the monitoring zone the sediment surfaces are not smooth and tend to be criss-crossed with both lateral (90° to the river axis) and longitudinal features (Figure 14C). The latter probably form as micro-cliffs at the water's edge during higher stage levels, or are very minor slump faces. The origin of the former is unclear; they seem to be degrading features and could either be formed as downslope rain-wash rills, or be the remnants of transverse bedforms (likely a mix of both origins).

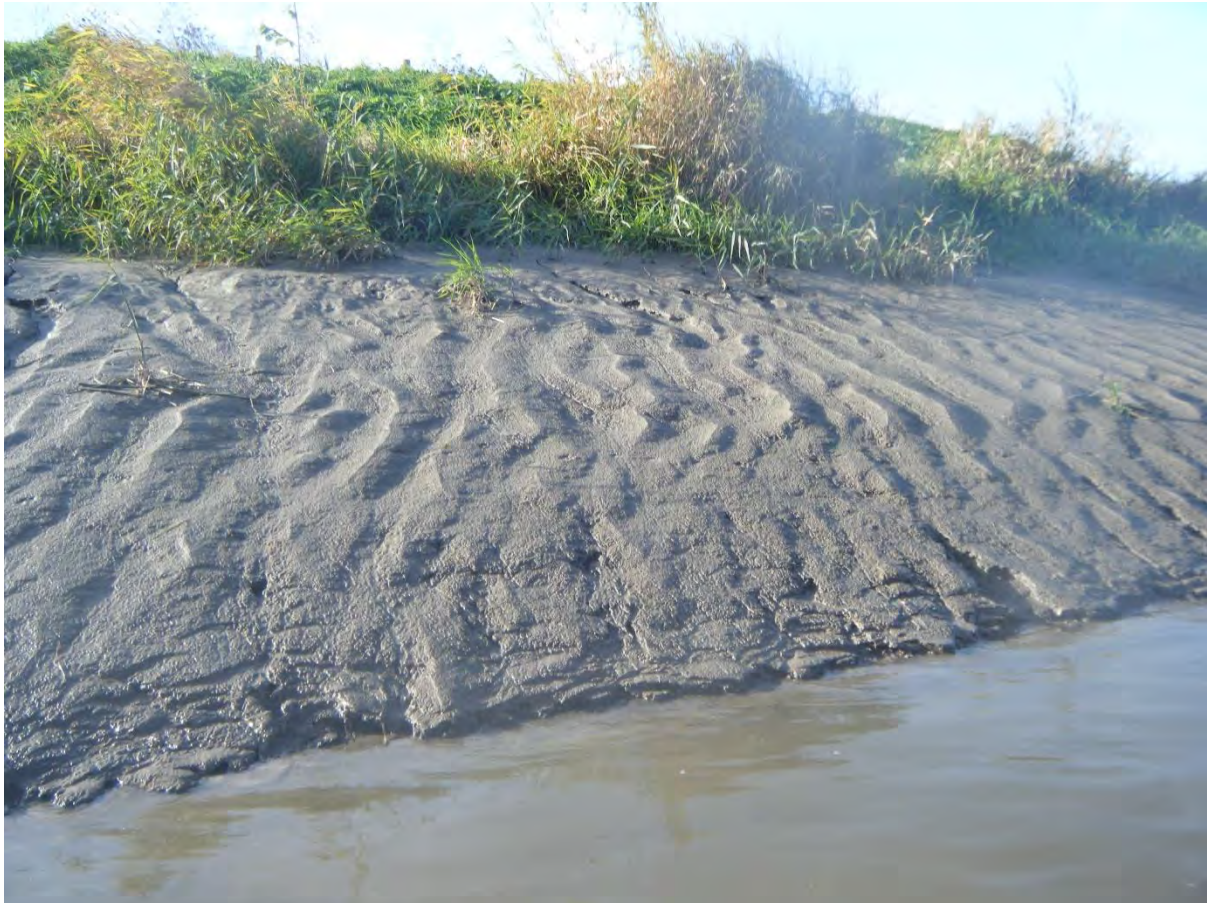
Figure 15. Site BS04 Left bank, showing transverse ripple marks and micro-cliffing.

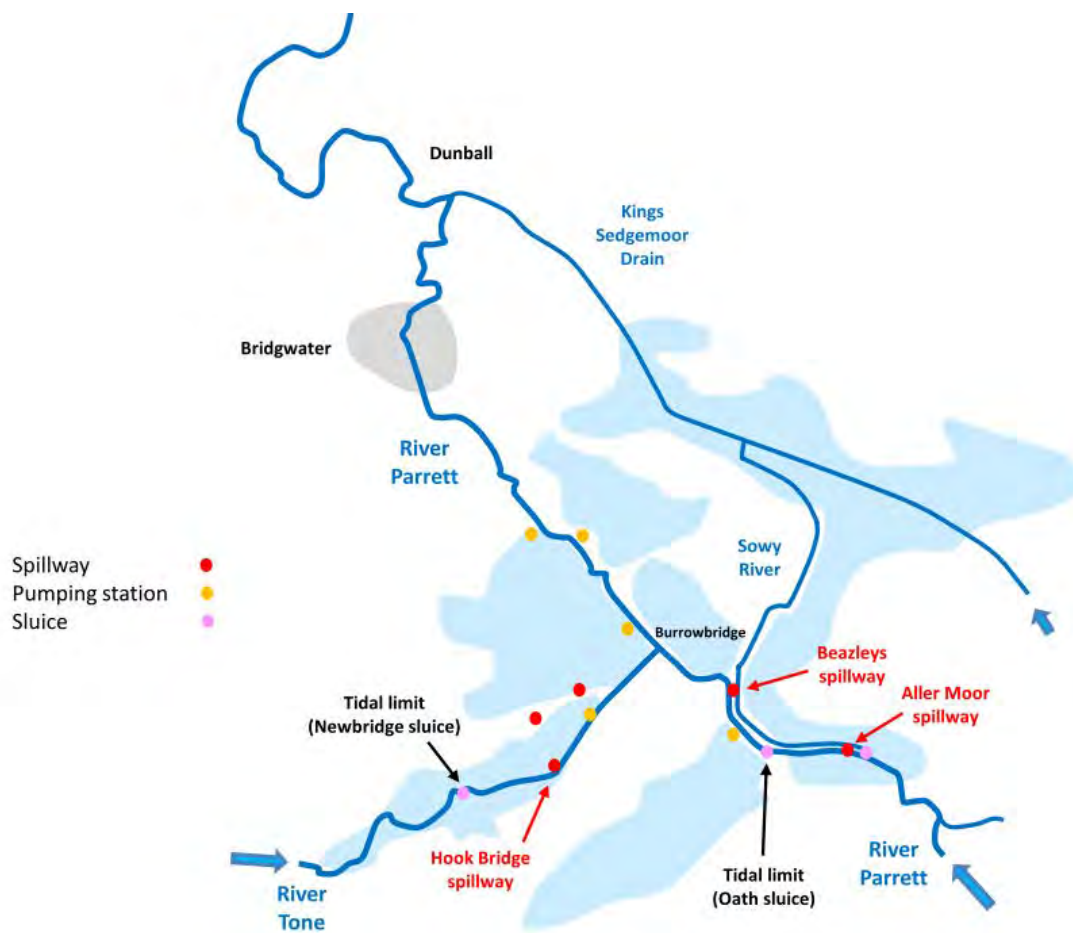
Figure 16. The Parrett and Tone: Drainage routes, spillways, pumping stations and water storage areas. The Severn Estuary is to the north (top).

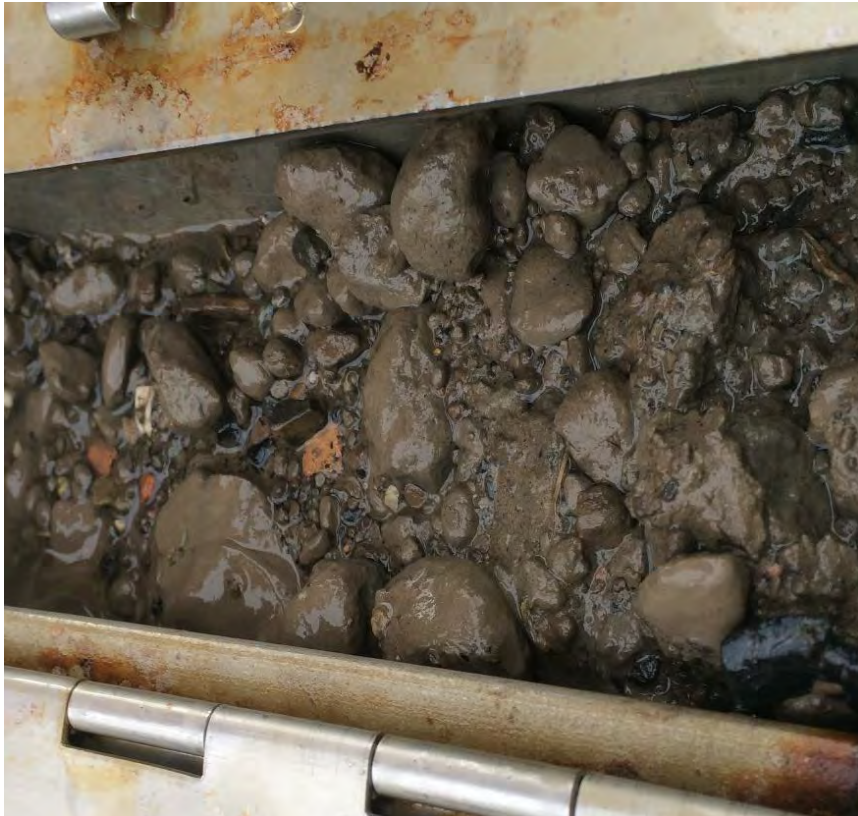
Figure 37. Sample B4-C showing presence of mud-clasts and fine gravel. Top: sediment surface seen in grab. Bottom: Gravel fraction from sample, post particle-size analysis (mud clasts dispersed).

- On the floor of the low water channel at Site 4 a completely new sediment type was seen. This contained 18% gravel, 18% sand and 64% mud. At the time of sample collection some of the mud was present as mud-clasts (Figure 37 top), showing recent break-up of a strongly cohesive mud bed. These clasts collapsed into mud particles on wet sieving. The actual gravel consisted of unencrusted, dull, angular to sub-rounded fine to medium gravel composed of shale and sandstone with some shell, wood and reed fragments (Figure 37 bottom).

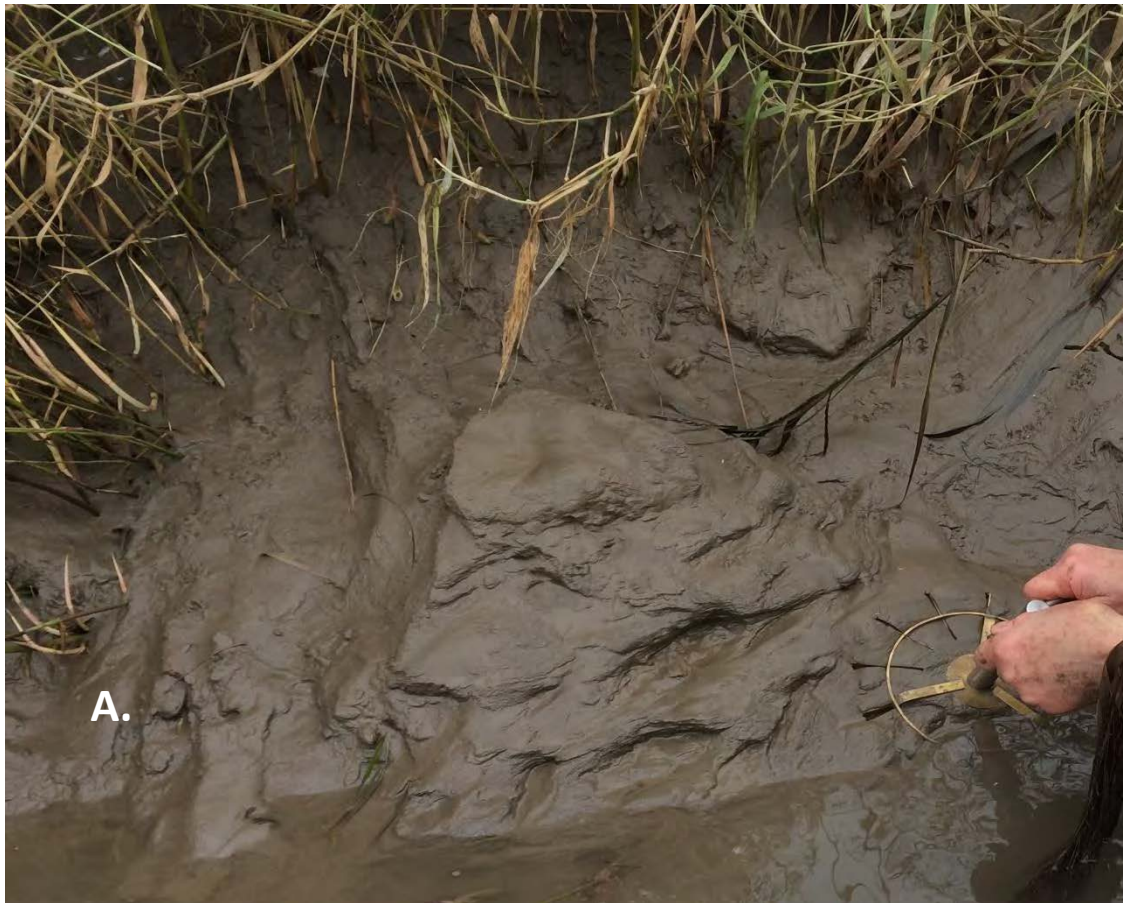
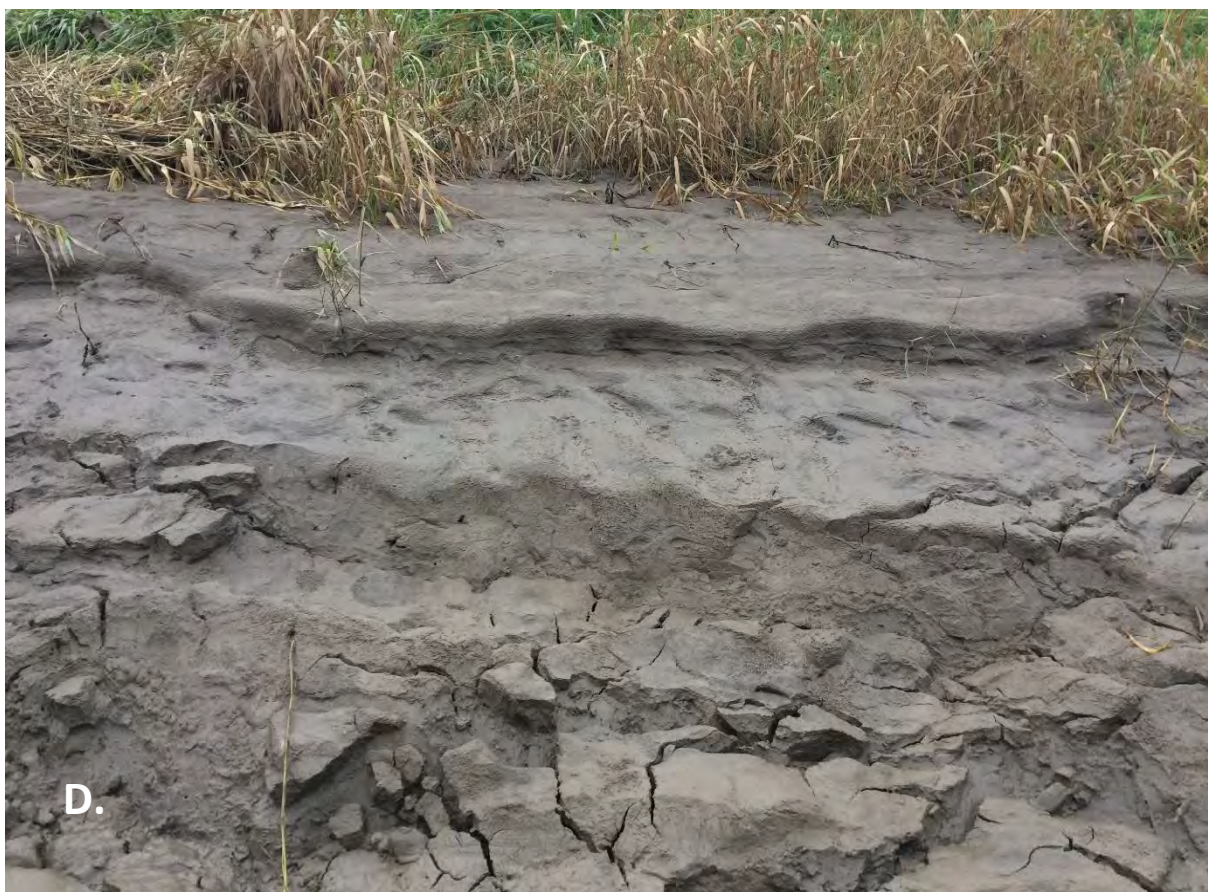
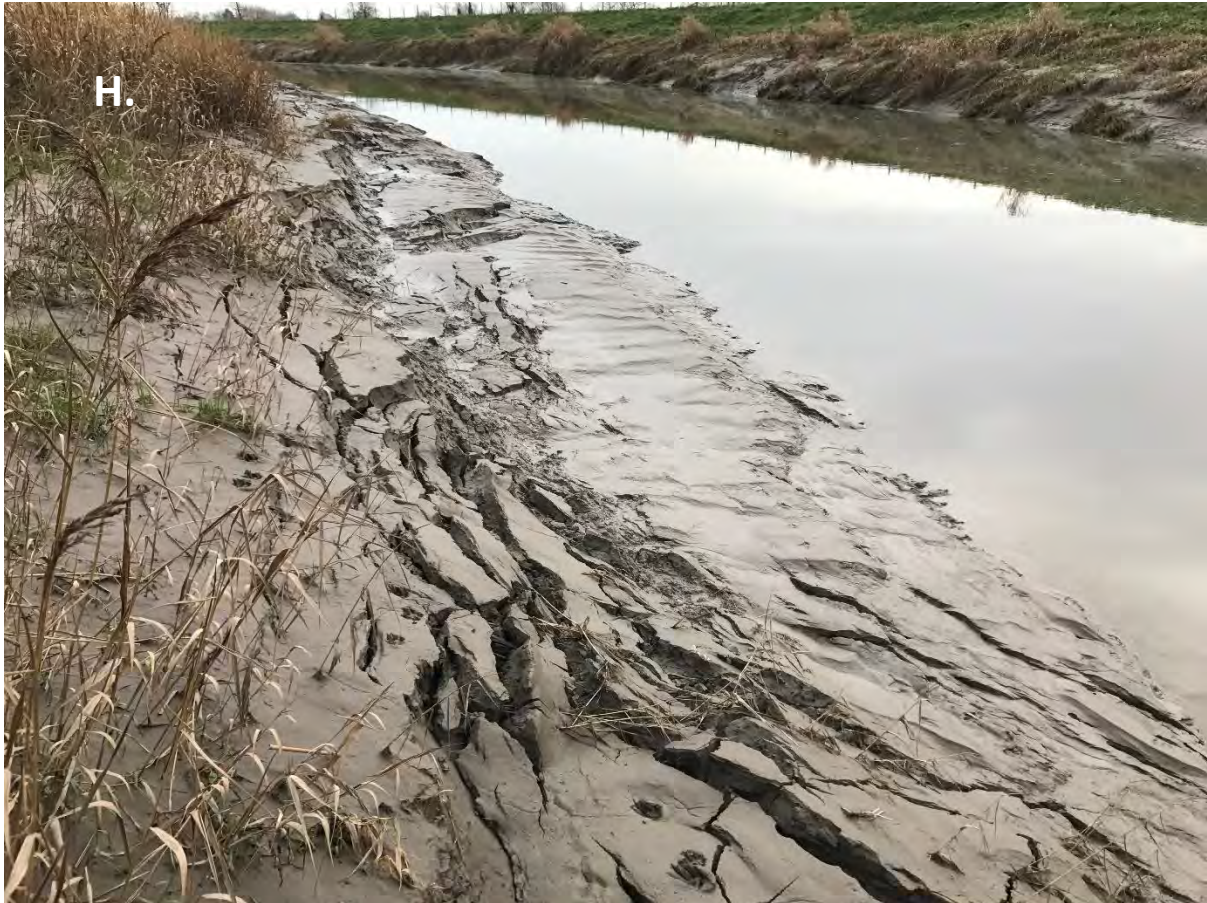
Figure 39. Photographs of sedimentary features on the intertidal. December 2016. ... continues.

Figure 39. Photographs of sedimentary features on the intertidal. December 2016.

- On straight reaches there were wide scoured sediment surfaces, again exhibiting the stepped appearance due to sediment layering, but less prone to slumping (Figure 39 F, Site B06).
