# Oath to Burrowbridge Dredging and Associated Activities

## Volume 3: Appendices Part 8 Section 2

## Oath to Burrowbridge dredge - working area

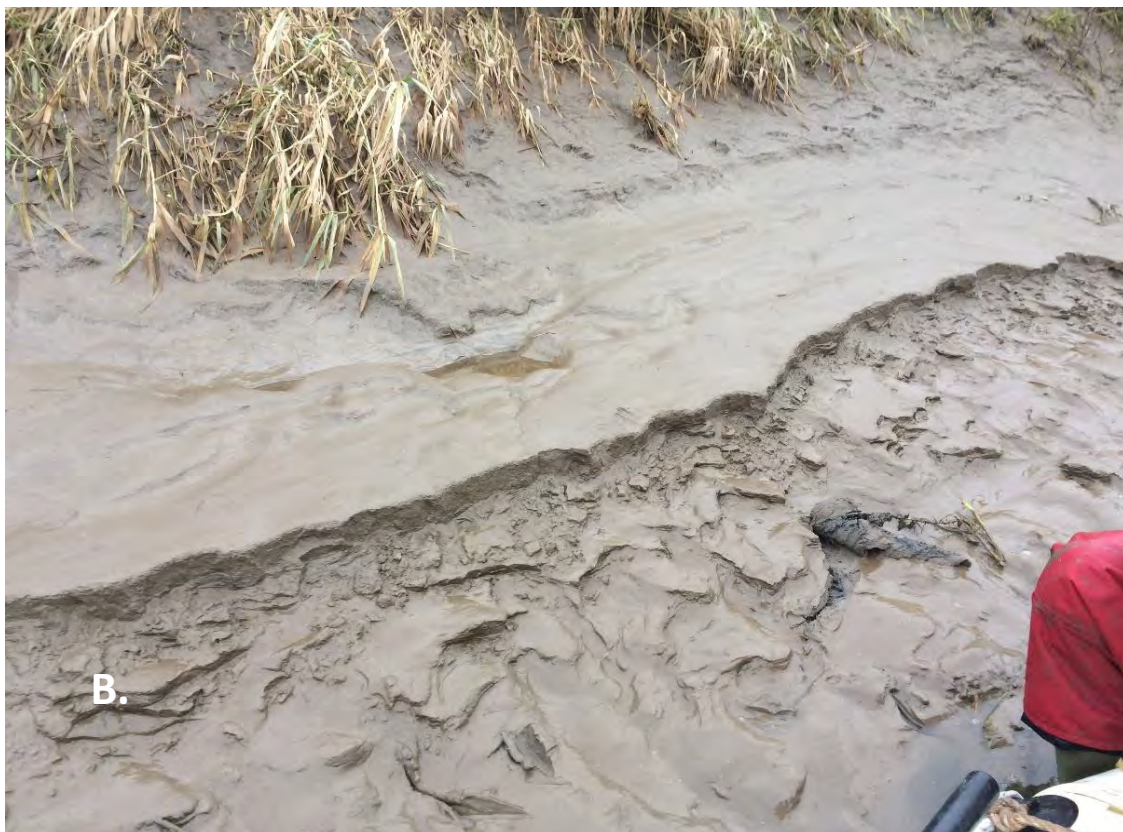
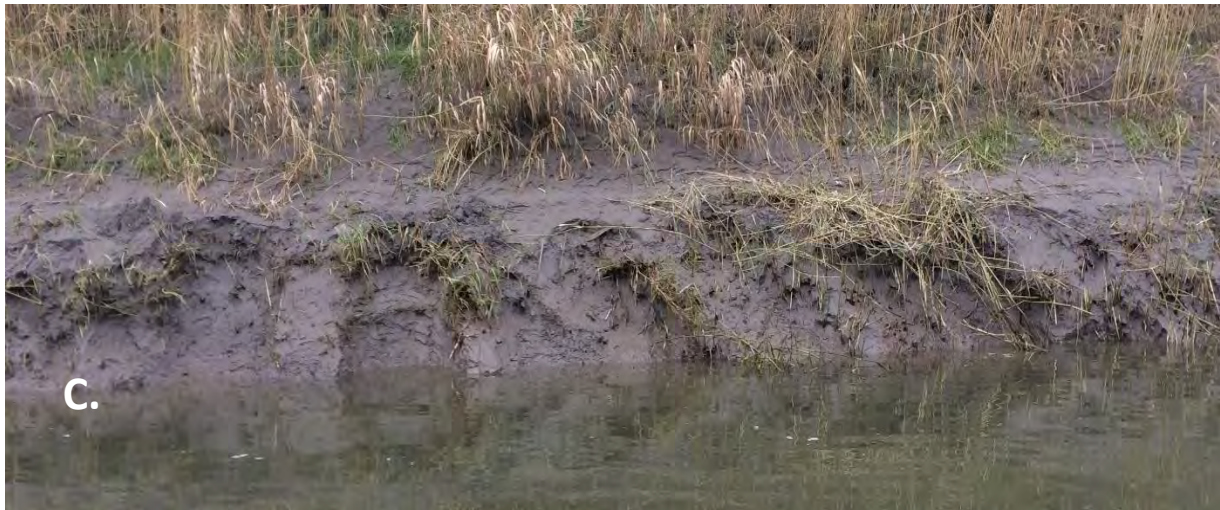
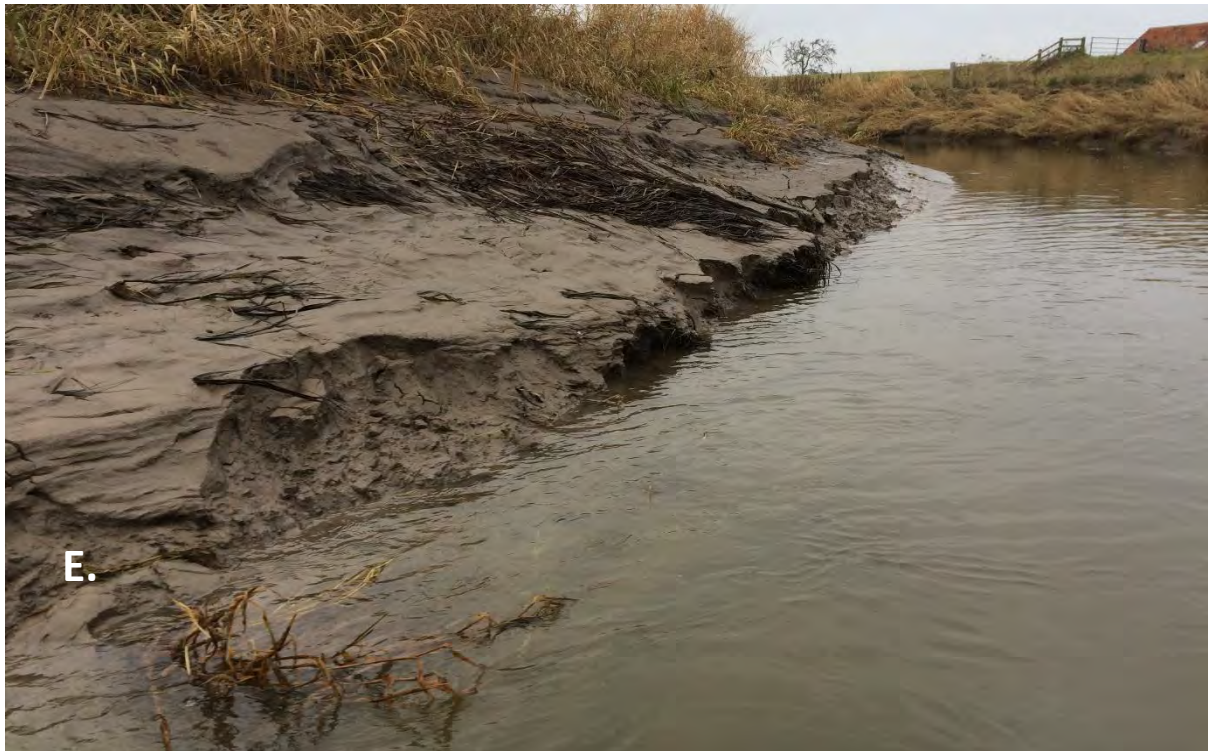
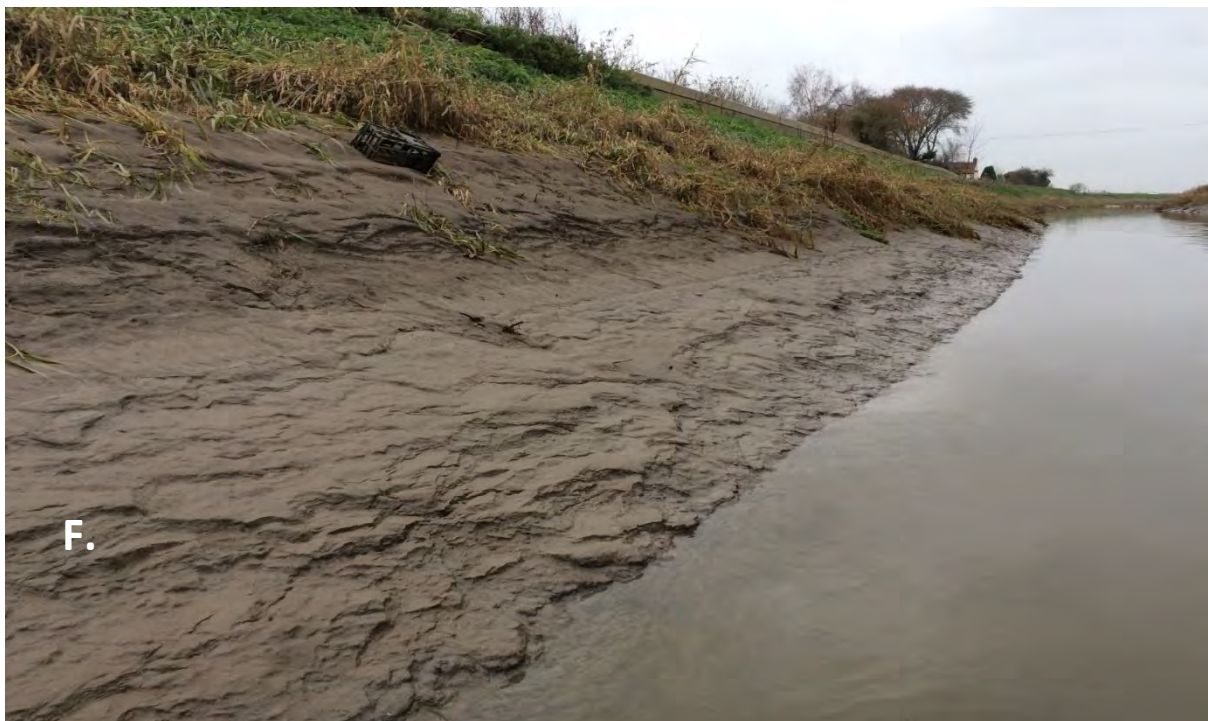
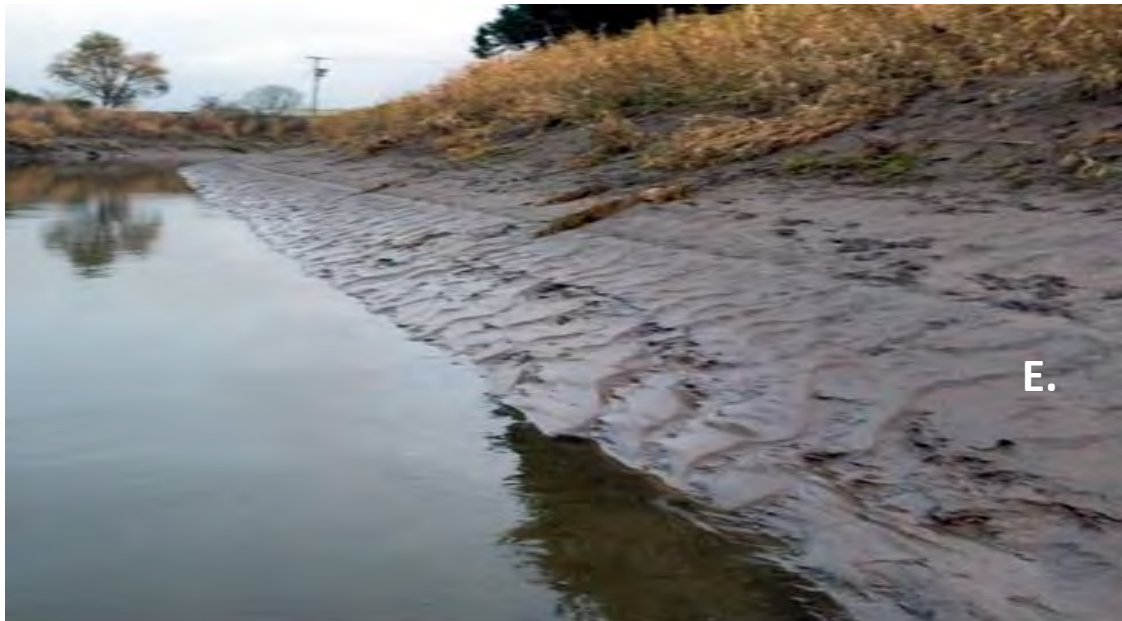
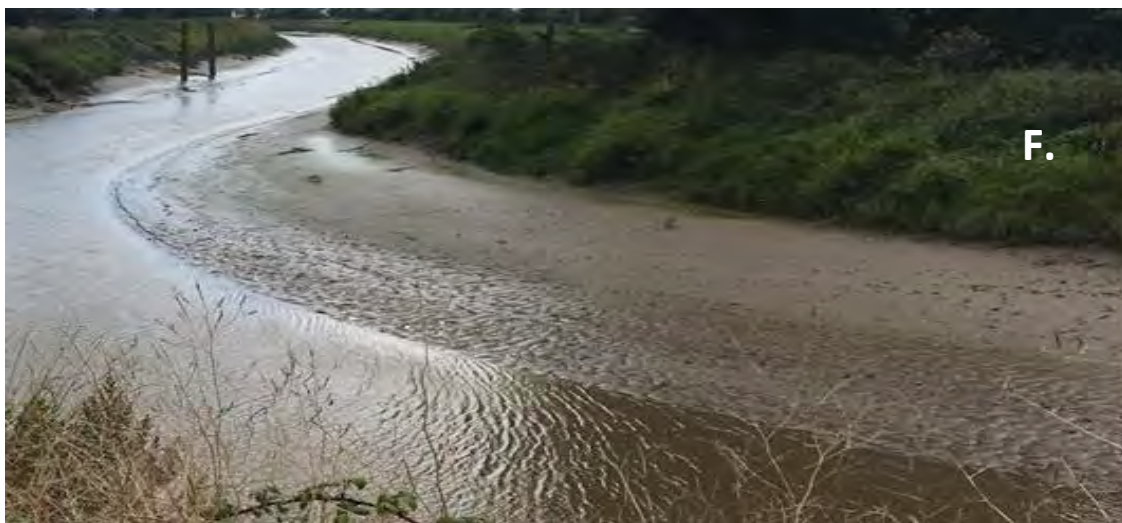
Figure 39. Photographs of sedimentary features on the intertidal. December 2016. ... continues.

Figure 39. Photographs of sedimentary features on the intertidal. December 2016..... continues.

Figure 39. Photographs of sedimentary features on the intertidal. December 2016.

- In the upstream reaches of the monitoring zone, most of the intertidal mud surfaces were similar to the pre-dredge condition, being featureless or showing erosion sculpting, quite strong in places (Figure 39 A, Site B02)

- At site 3, within the dredged zone, erosion features became stronger, with micro-cliffs often separating an upper-bank featureless zone from a lower highly eroded zone (Figure 39 B, Site B03). The cliff is probably the result of water-margin erosion during (recent) higher river stage. It can be seen that the erosion of the bed reveals that the exposed sediment is strongly layered (evidence of deposition in incremental layers separated by time and/or an erosion period).

- For long sections of the bank downstream of Site B03, the cut marks of the Farrell dredger (made at time of highest river flow) were evident (Figure 39 C).

- At site B04 (lower end of dredge reach) the banks were often eroded and stepped, with crack-development leading to the release of large blocks of mud (Figure 39 D, site B04).

- Most erosion was seen on inner-bend slip-off slopes, where large slump features had developed (Figure 39 E, between Sites B04 & B05). The slump faces again show that the exposed sediment has highly layered properties.

- On straight reaches there were wide scoured sediment surfaces, again exhibiting the stepped appearance due to sediment layering, but less prone to slumping (Figure 39 F, Site B06).

Through the dredge zone, some very large bank slumps developed through the weeks following dredging. The image seen in Figure 39 H was taken on 21st December.

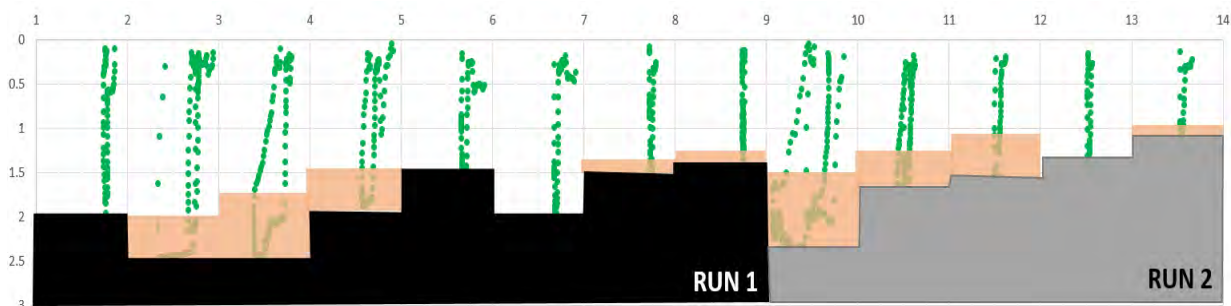
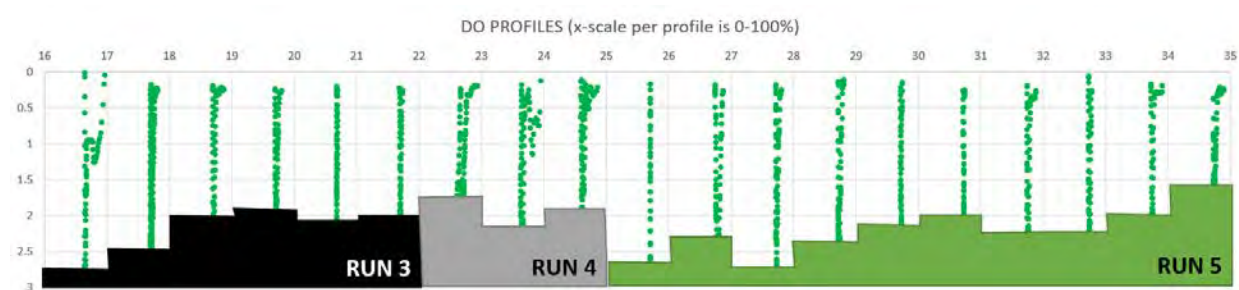
Figure 48. Dissolved oxygen profiles during the WID trials. Figure 48. Dissolved oxygen profiles during the Farrell trials. X-axis is scaled to 100% per profile, y-axis is depth below water surface.
