# Oath to Burrowbridge Dredging and Associated Activities

Volume 3: Appendices Part 5

APPENDIX 6F: INVERTEBRATES

# RESULTS OF A SURVEY FOR THE HAIRY CLICK-BEETLE SYNAPTUS FILIFORMIS ON THE RIVER PARRETT IN SOMERSET

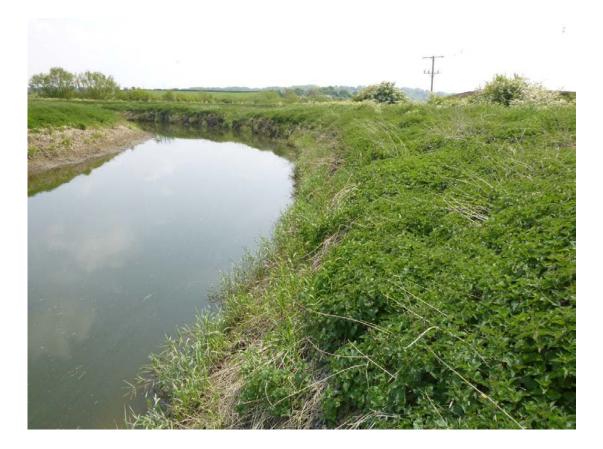
Photo 2. River Parrett Sample Location 2 upstream from ST 37870 28182; showing a steep substrate, poor habitat structure and reed canary-grass limited to a narrow fringe on the water margin.

to Location 1 and no adults or larvae were recorded. Photo 2 illustrates the character of the habitat present in Sample Location 2.

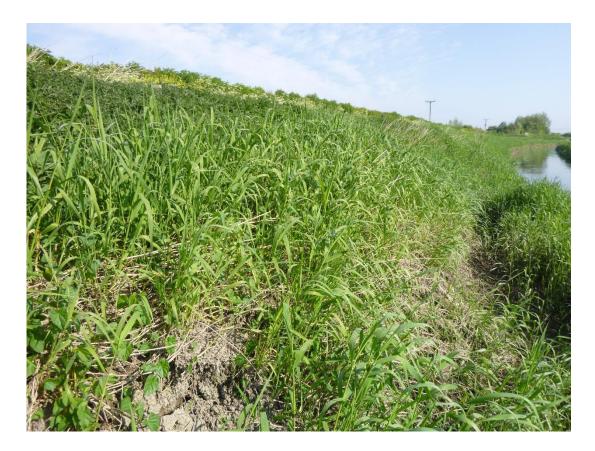
Photo 3. River Parrett Sample Location 2 downstream from ST 36557 29555; where two adult hairy click-beetle were swept.

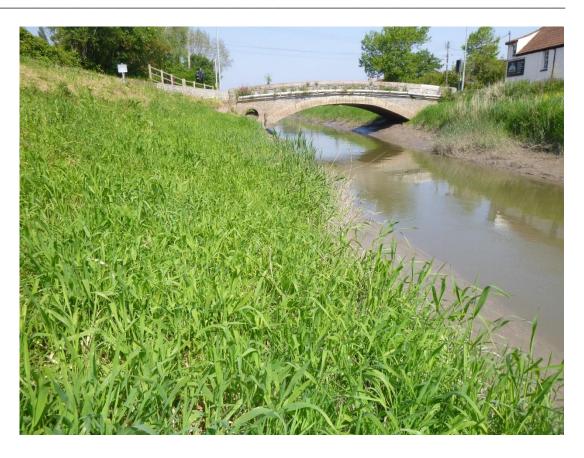
Photo 4. River Parrett Sample Location 6 downstream from ST 35795 30341; the reed canary-grass had recently been cut close to the river channel.

6.8.1 Sample Location 6 comprised a 280 m section upstream of Burrowbridge from ST 35741 30425 to ST 35805 30164. Although the lower channel face is shallow with a *c*. 20° slope and has good quantities of reed canary-grass, much of the vegetation has been cut close to the river channel and is therefore not typical of the habitat structure exploited by hairy click-beetles. Despite annual records of hairy click-beetle from Environment Agency surveillance between 2010 and 2016, no adults or larvae were recorded. Photo 4 illustrates the habitat present.

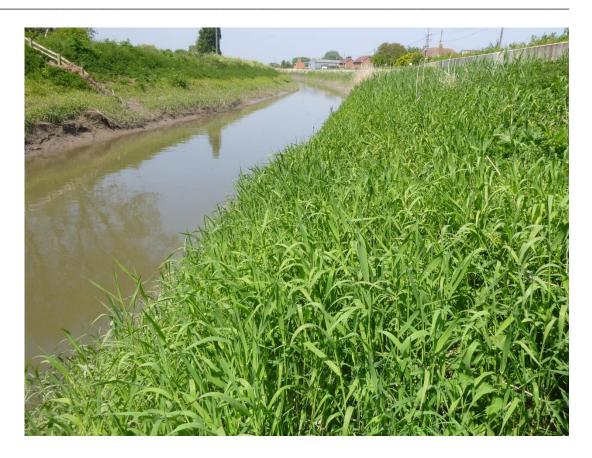
Photo 5. Sample Location 7 downstream from ST 35720 30493; where three adult hairy click-beetle were swept.

6.9.1 Sample Location 7 comprises a 250 m section of the River Parrett bank downstream of Burrowbridge from ST 35749 30449 to ST 35602 30641. This sample was surveyed on the Burrowbridge side alone. The habitat here comprised a 3-4 m belt of unmanaged reed canary-grass dominated vegetation with common reed, growing on a shallow lower channel face with a *c*. 20-30° slope. This is a locality with previous records of hairy click-beetle, and three adults were recorded in 2018, but no larvae were encountered in a soil-pit. Photo 5 illustrates the habitat present in 2018.

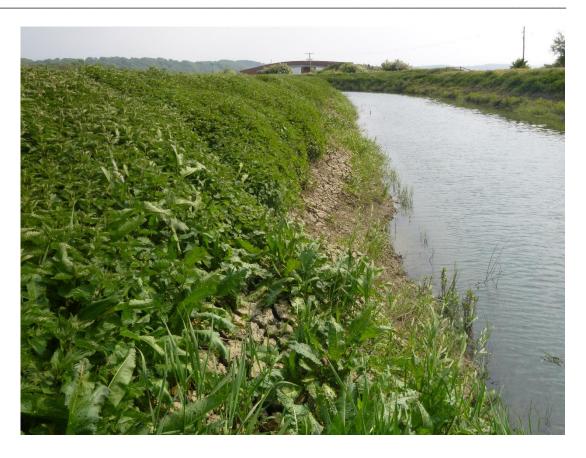
Photo 6. River Parrett downstream from ST 38143 22977; unmanaged bank with poorly developed reed canary-grass zone.

6.10.2 A 430 m section of river bank to Oath Lock was surveyed on the Burrowbridge side, from ST 38119 28143 to ST 38275 27886. The habitat here comprises dense ruderal vegetation on the upper bank, and scattered reed canary-grass along a largely bare 1-1.5 m strip above the river channel (see Photo 6). No adult hairy click-beetles were recorded.

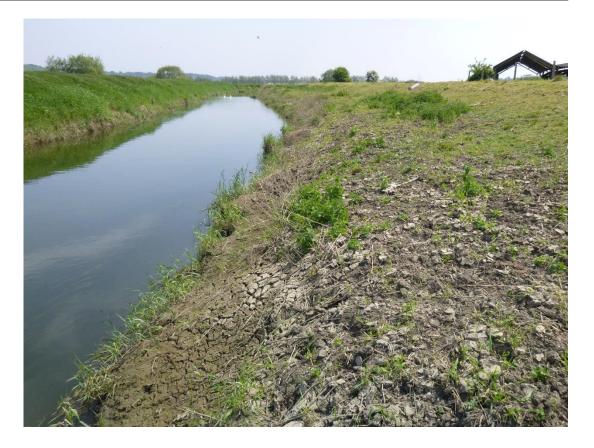
Photo 7. River Parrett upstream from ST 37946 28141; heavy poaching from cattle grazing, with limited growth of reed canary-grass.

6.10.3 The Stathe bank of the River Parrett between ST 37937 28143 and ST 38113 27943 was visually inspected from adjacent sections, and the opposite bank. This section was heavily grazed by cattle, with limited growth of reed canary-grass (see Photo 7) and the habitat is not typical of that known to be exploited by hairy click-beetles.

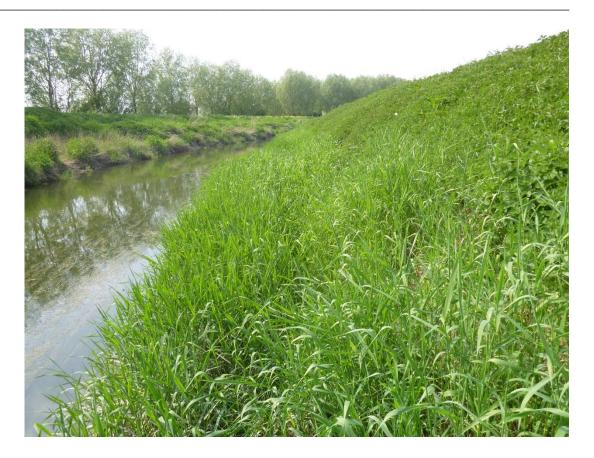
Photo 8. River Parrett downstream from at ST 37923 28162; where an adult hairy click-beetle was swept.

6.10.4 A 1.3 km section of river bank upstream from the eastern end of Southlake Moor was surveyed on the Burrowbridge side, from ST 37538 29099 to ST 38119 28143. The habitat here comprises a monotypic 1-3 m belt of unmanaged reed canary-grass growing on a shallow lower channel face with a *c*. 20-30° slope (see Photo 8). Fourteen adult hairy click-beetle were recorded, but no larvae were encountered in a soil-pit.

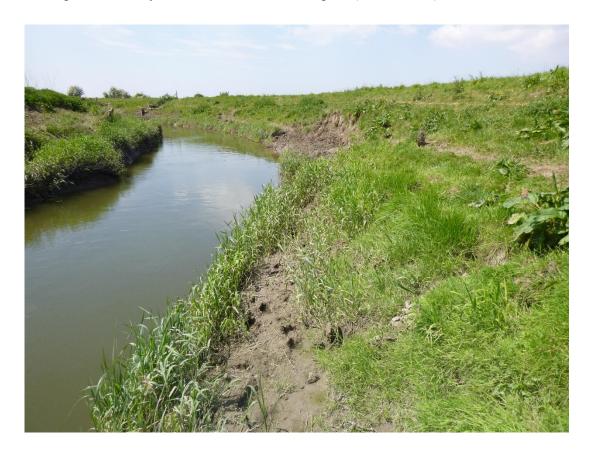
Photo 9. River Parrett downstream from ST 37194 29553; poaching from cattle grazing, with limited growth of reed canary-grass.

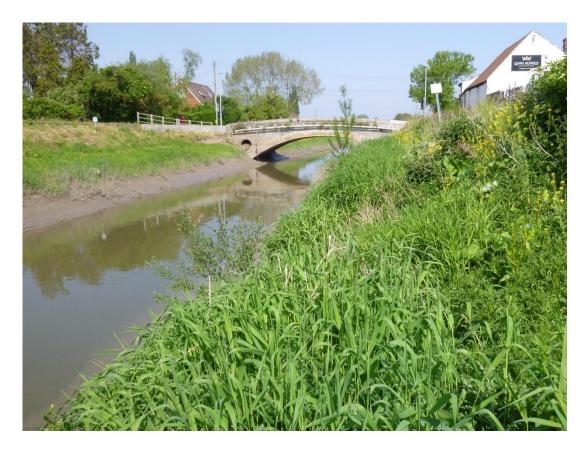
# Photo 10. River Parrett downstream from ST 35784 30389; where an adult hairy click-beetle was swept.

6.10.8 A 100 m section of the River Parrett bank upstream from Burrowbridge was surveyed on the Burrowbridge side, from ST 35754 30436 to ST 35811 30348. The habitat here comprises diverse ruderal vegetation and a 1-2 m belt of unmanaged reed canarygrass. The lower channel profile is steep (c. 45°), with a slightly shallower mid-slope (c. 35°) (see Photo 10). One adult hairy click-beetle was recorded.

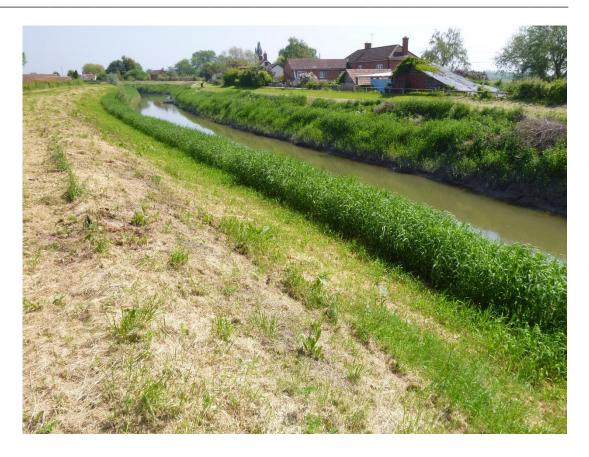
Photo 11. River Tone downstream from ST 35617 29955; with a 2 m belt of reed canary-grass left unmanaged, after cutting on the upper bank.

6.11.2 The habitat on the south bank of the River Tone between ST 35798 30144 and ST 35396 29721 comprised a monotypic 2-3 m belt of reed canary-grass growing on a shallow lower channel face with a c. 20-30° slope. Although the habitat composition and structure are typical of that known to be exploited by hairy click-beetles, access permissions had not been gained and no survey was performed. The status of the species in this location therefore remains unknown.

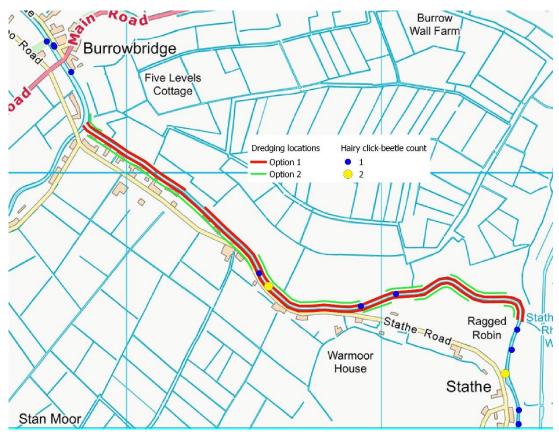
Figure 5. The sections of the River Parrett where dredging is proposed, and the locations where hairy click-beetles were recorded in 2018.

- 7.1.2 Dredging is proposed in the sections of channel shown on Figure 5. There are two options: -
  - 1. Option 1 Maximum flood risk benefit of works; and
  - 2. Option 2 Single bank only mitigation.

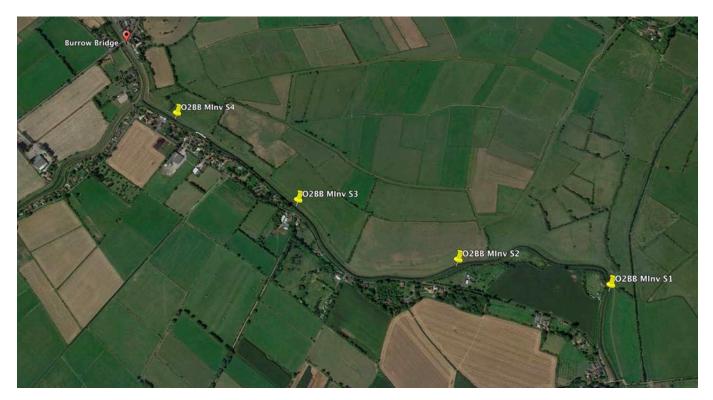
Figure 1: Location of the benthic macroinvertebrate sample points (S1, S2, S3 and S4). Sample point S1 is located just downstream of Oath Lock

Macroinvertebrate samples were taken from four discrete locations downstream of Oath Lock (see Figure 1), as shown in Table 1.

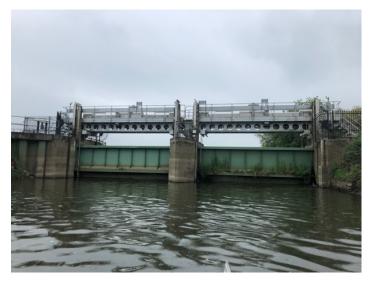
Plate 1: Oath Lock forming the tidal limit, reducing summer freshwater flow and impeding fish passage

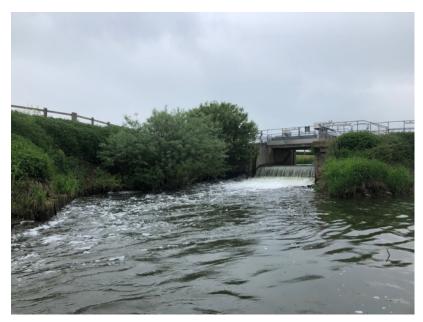
Plate 2: Freshwater flow over control structure at Oath Lock creating attractant flow to support fish passage upstream

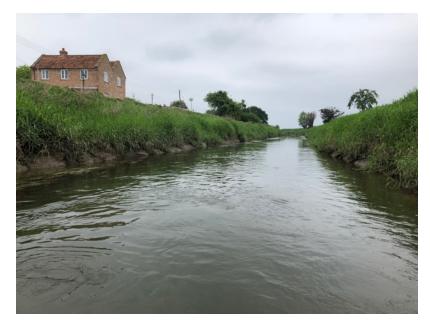
Plate 3: Typical view showing re-sectioned and re-aligned planform, influence of tide on water levels, smooth flow, no in-channel habitat/features from trees

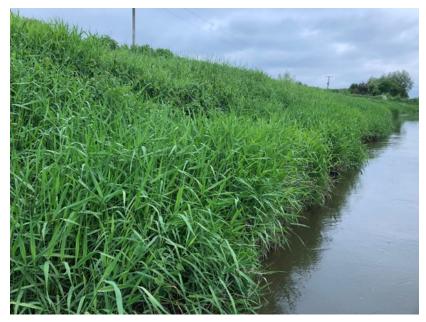
Plate 4: Typical view showing increased proximity to upper bank vegetation at higher/freshwater flow tidal states.

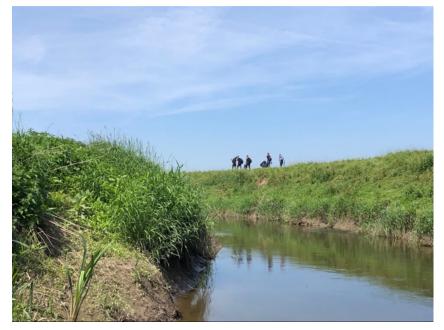
Plate 5: Typical view of gentle bend without typical meander geomorphology

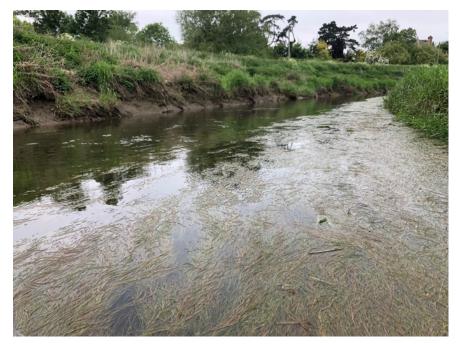
Plate 6: Typical appearance of submerged aquatic macrophyte bed at lower flows/tidal states, providing a dense submerged and lower energy habitat for fish and invertebrates with greater flow passing to the side

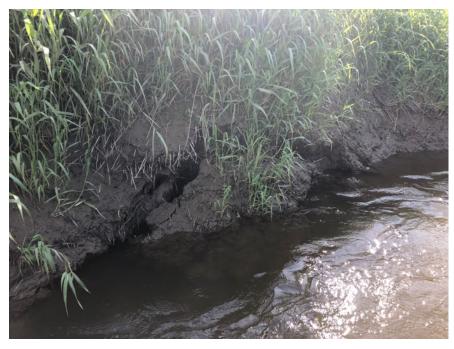
Plate 7: Bank failure in progress resulting in the provision of fresh sediment in-channel (potential for localised depth reduction until transported) and small embayment/overhang that could develop further during higher energy flow events.

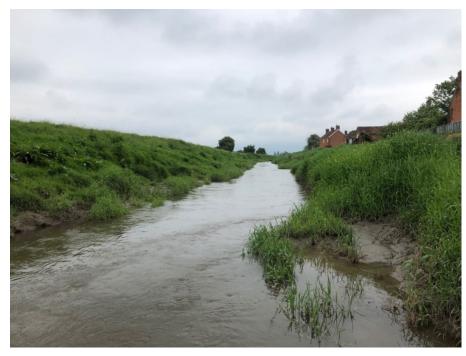
Plate 8: Stabilised and vegetated bank collapse creating shallow backwater/embayment at higher flow conditions and a narrowing/pinch point in the channel at lower flow conditions, locally increasing flow velocity.

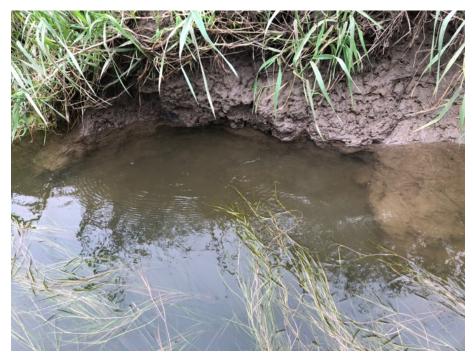
Plate 9: Submerged lower energy feature caused by bank failure, adjacent to macrophyte bed

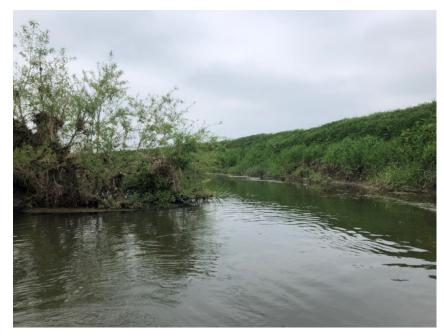
Plate 10: Rare overhanging/submerged habitat features (depending on tidal/freshwater flow state) associated with bankface willow.

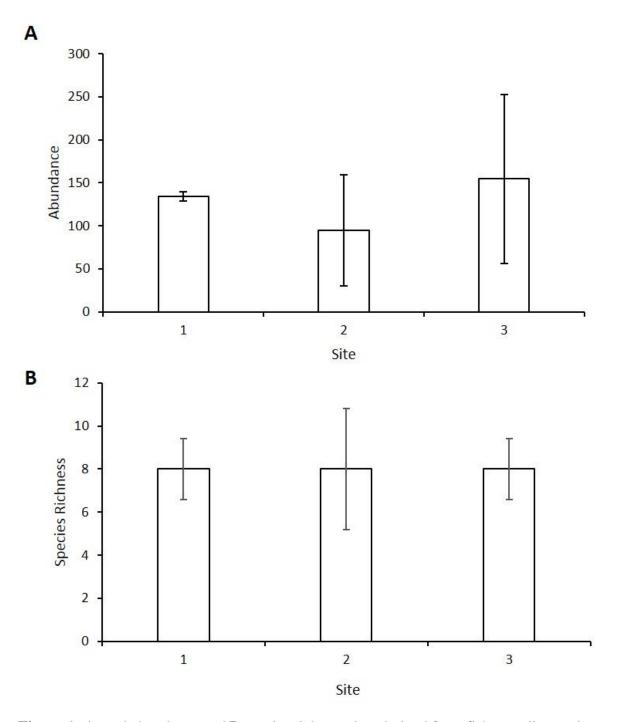
**Figure 1:** A total abundance and **B** species richness data derived from fish sampling at sites 1, 2 and 3. Presented are site means  $(n = 2) \pm \text{STDEV}$ .

A total of 766 fish, representing 13 species (Thin-lipped Grey Mullet Chelon ramada: total abundance = 2, mean total length =  $7.6 \pm 0.8$  cm; Tench *Tinca tinca*: total abundance = 1, mean total length =  $13.50 \pm 0$  cm; Common bleak *Alburnus alburnus*: total abundance = 248, mean total length =  $9.0 \pm 2.6$  cm; Roach *Rutilus rutilus*: total abundance = 183, mean total length =  $12.6 \pm 3.6$  cm; Gudgeon *Gobio gobio*: total abundance = 91, mean total length =  $9.8 \pm 1.9$  cm; Pike *Esox lucius*: total abundance = 6, mean total length =  $49 \pm 20.4$  cm; Common Bream Abramis brama: total abundance = 54, mean total length =  $14.9 \pm 6.1$  cm; Chub Squalius *cehalus*: total abundance = 86, mean total length =  $15.3 \pm 8.6$  cm; Flounder *Paralichthys dentatus*: total abundance = 7, mean total length =  $7.1 \pm 2.5$  cm; European Eel Anguilla Anguilla: total abundance = 48, mean total length =  $22.9 \pm 5.8$  cm; Perch Perca fluviatilis: total abundance = 26, mean total length =  $15.2 \pm 2.7$  cm; Roach *Rutilus rutilus* - Common Bream Abramis brama hybrid: total abundance = 12, mean total length =  $20.2 \pm 6.2$  cm; Rudd Scardinius erythrophthalmus: total abundance = 2, mean total length =  $15.1 \pm 1.3$  cm;  $\pm$ STDEV) were recorded during the multi-pass electric fishing surveys. As expected, the majority of captured individuals (757, representing 99% of the total catch) were freshwater rather than marine fish. Fish communities were similar between sites with mean abundance and species richness values calculated as 134 and 8, 94.5 and 8 and 154.5 and 8 for sites 1, 2 and 3, respectively (Figure 1). On average, common Bleak Alburnus alburnus, Roach Rutilus rutilus, Gudgeon Gobio gobio, Common Bream Abramis brama, Chub Squalius cehalus and European Eel Anguilla Anguilla were most prevalent, in terms of abundance, across sites (Figure 2). Piscivores, including Pike Esox Lucius, Chub Squalis cephalus and Perch Perca fluviatilis were present at each of the surveyed sites. The European Eel Anguilla anguilla was observed at each of the sites with the greatest mean abundance (21; Figure 2) recorded near the confluence, at site 3.

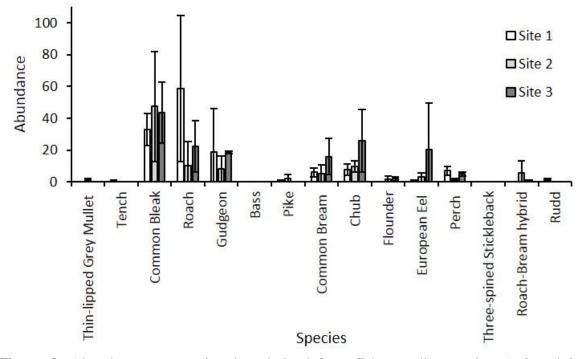
**Figure 2:** Abundance per species data derived from fish sampling at sites 1, 2 and 3. Presented are site means  $(n = 2) \pm STDEV$ .
